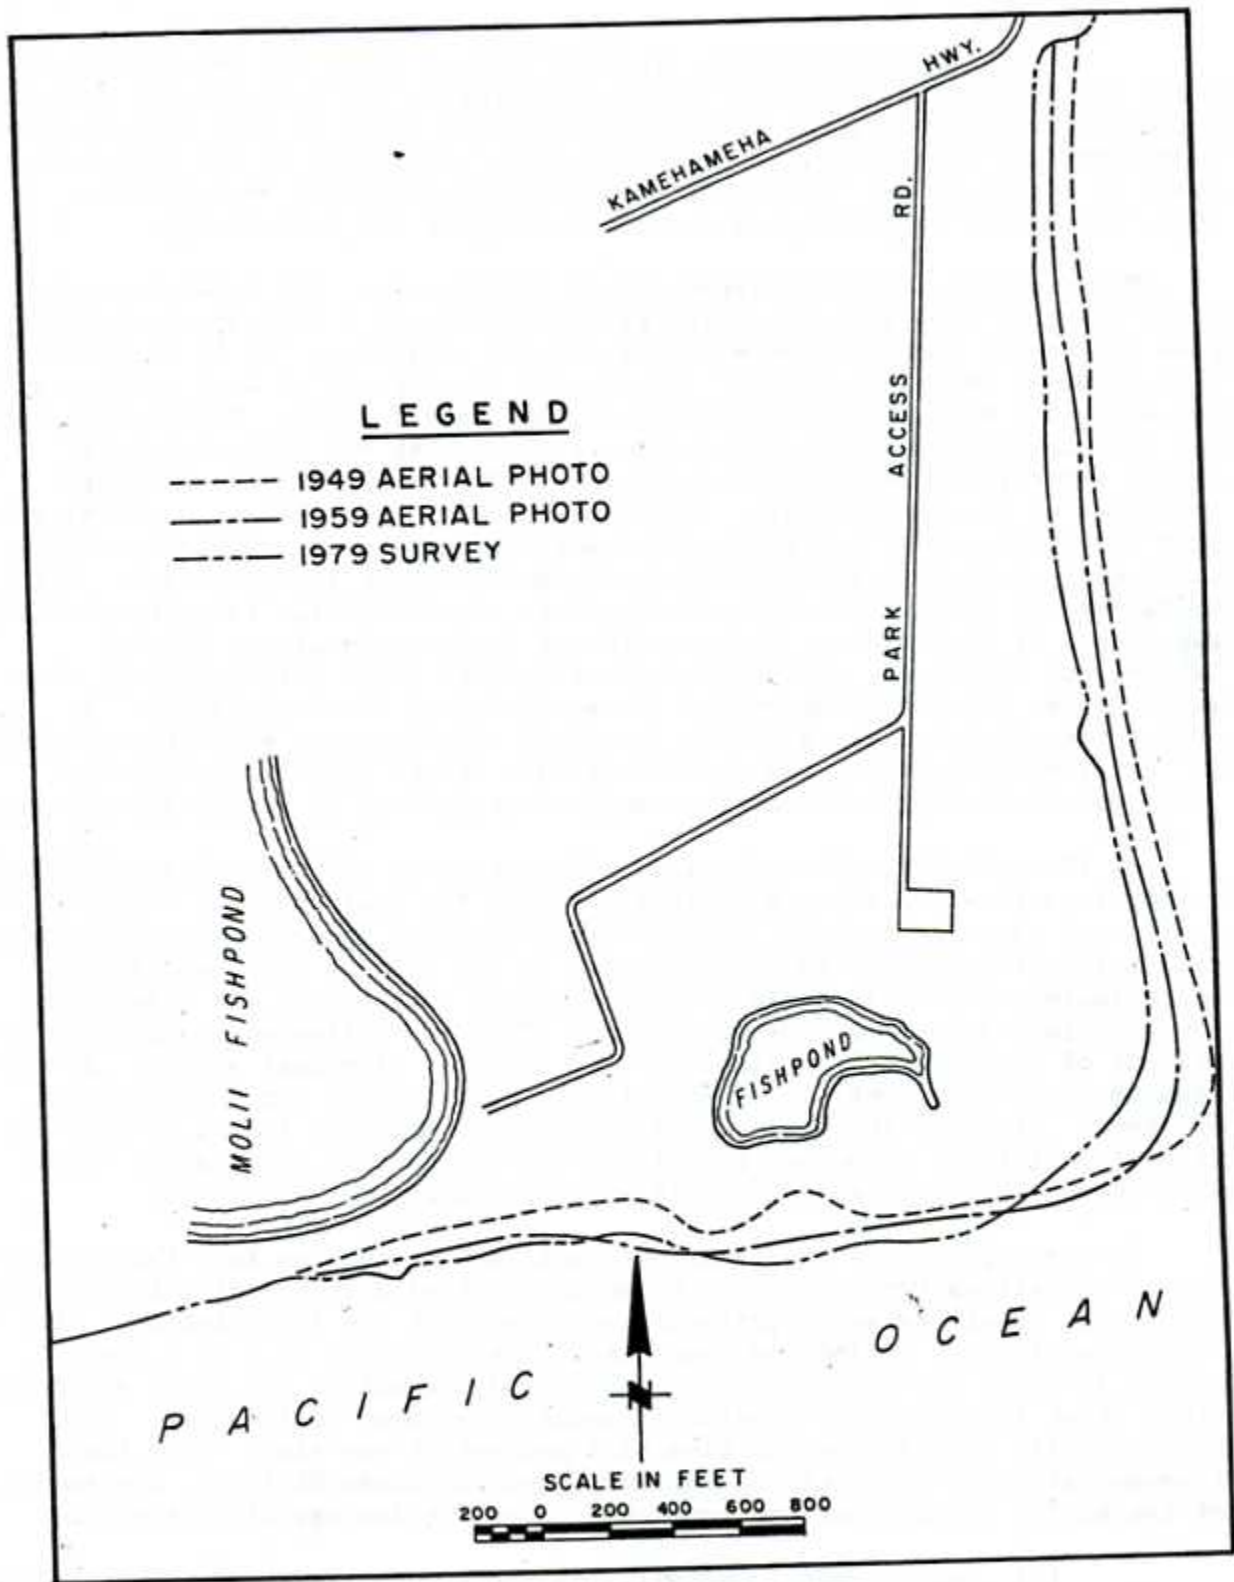
(d) The Problem. The eastern beach at Kualoa Regional Park has undergone continuous erosion. Resulting shoreline changes are shown in Figure 2-598. The average annual loss of sand from the eastern beach area from 1949 to 1975 was 4,800 cubic yards. During this period, the eastern shoreline had receded at an average rate of about 4 feet per year, and the shoreline near Kualoa Point had receded at about 7 feet per year. Although most of the park's southern shoreline accreted during 1949-75, there was a net loss of 80,000 cubic yards for the whole park. This represents more than 6 acres of parklands lost. Studies have indicated that, from 1949 to 1975, 30,000 cubic yards of sand was lost from the littoral system at Kualoa, probably to the offshore sand deposit south of Moli'i Fishpond. Beach erosion appears almost continuous during trade-wind conditions, and a period of higher than normal tides under typical trade-wind conditions can accelerate shoreline erosion.

Figure 2-598. Shoreline changes at Kualoa Park.

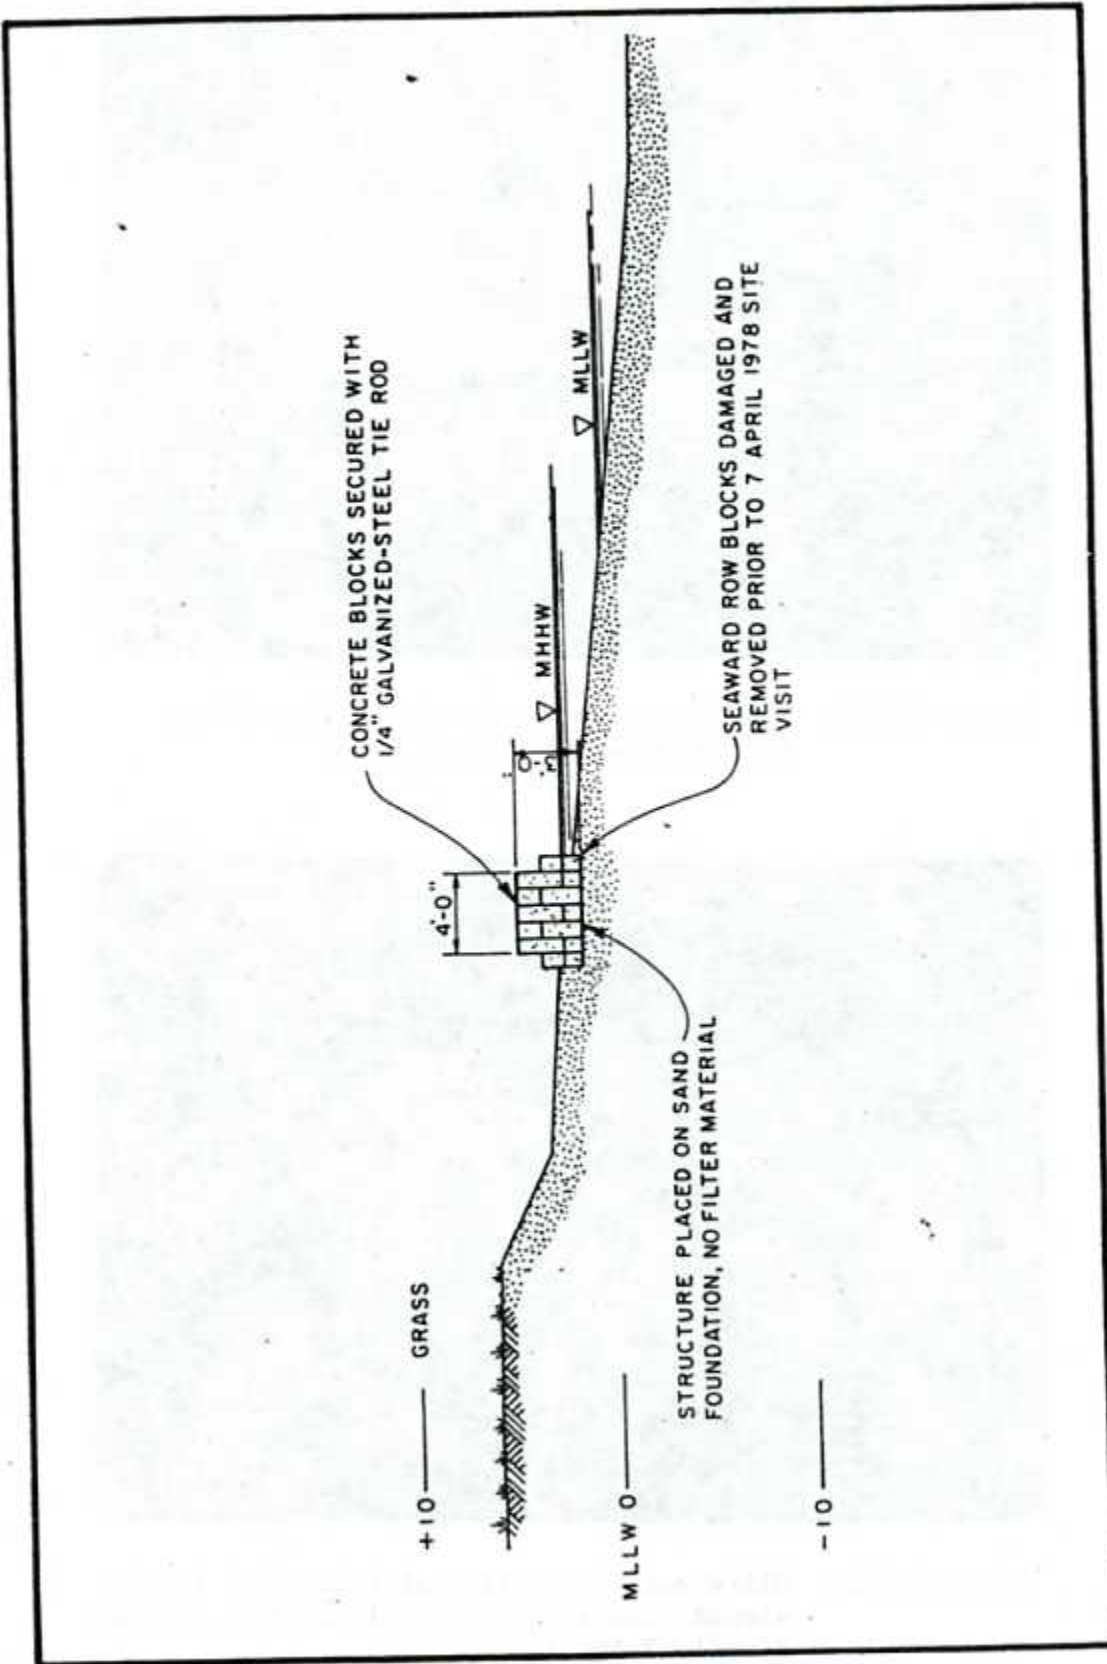
Figure 2-599. Sandgrabber profile at Kualoa site.

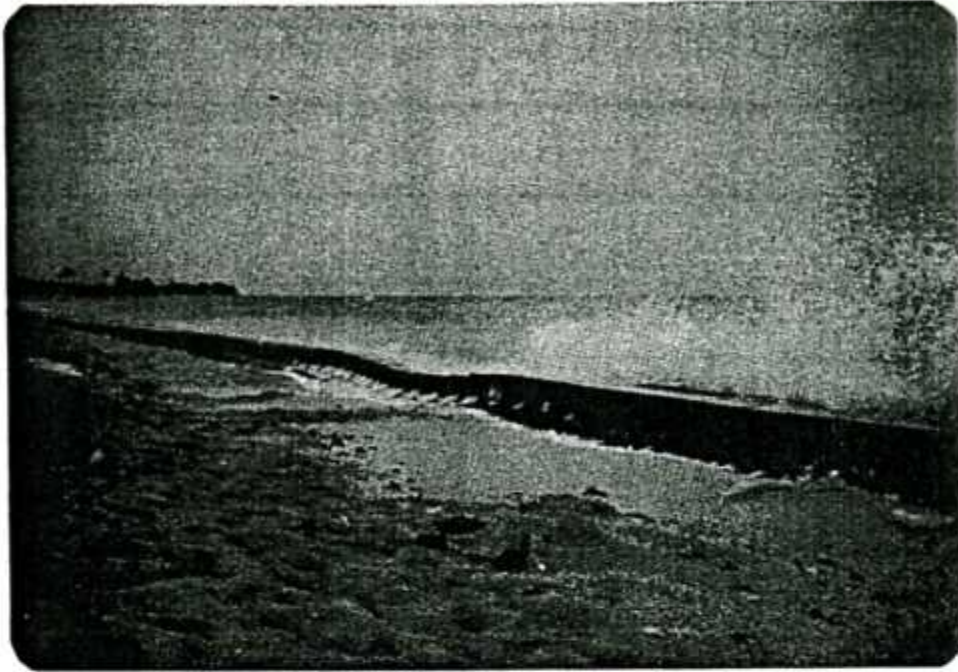
(3) Performance. Overall, the Sandgrabber remained structurally sound throughout the monitoring period. Differential settlement along its midsection, and of individual blocks, was observed in April 1978 (Figs. 2-600 and 2-601). The entire structure was also rotating downward on the seaward side. The short section on the south end had a seaward slope of 13° (Fig. 2-602). By May, although this short section had continued to settle, the seaward slope was only 8°.

Figure 2-600. Settlement of blocks along midsection, Kualoa, Hawaii, 7 April 1978.

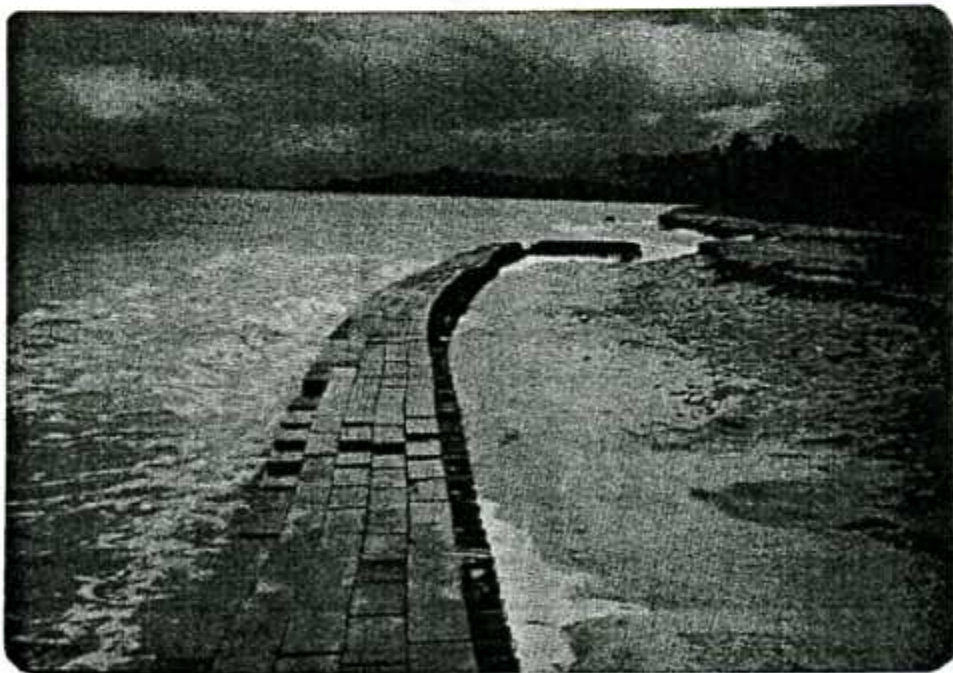
Figure 2-601. Differential settling of individual blocks viewed from structure's midsection, Kualoa, Hawaii, 7 April 1978.

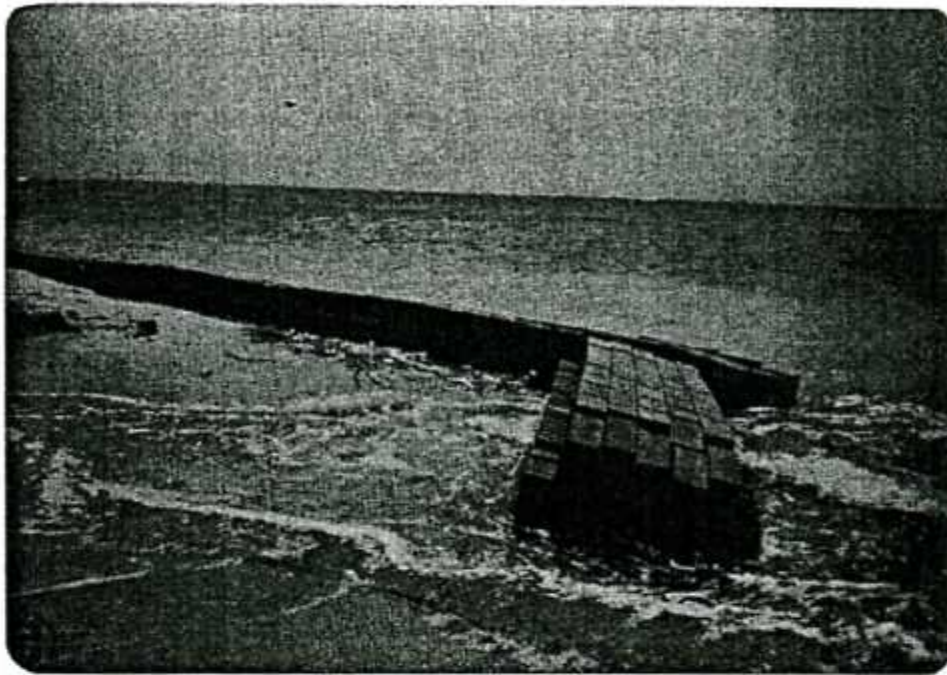
Figure 2-602. Seaward slope of south end of Sandgrabber, Kualoa, Hawaii, 7 April 1978.

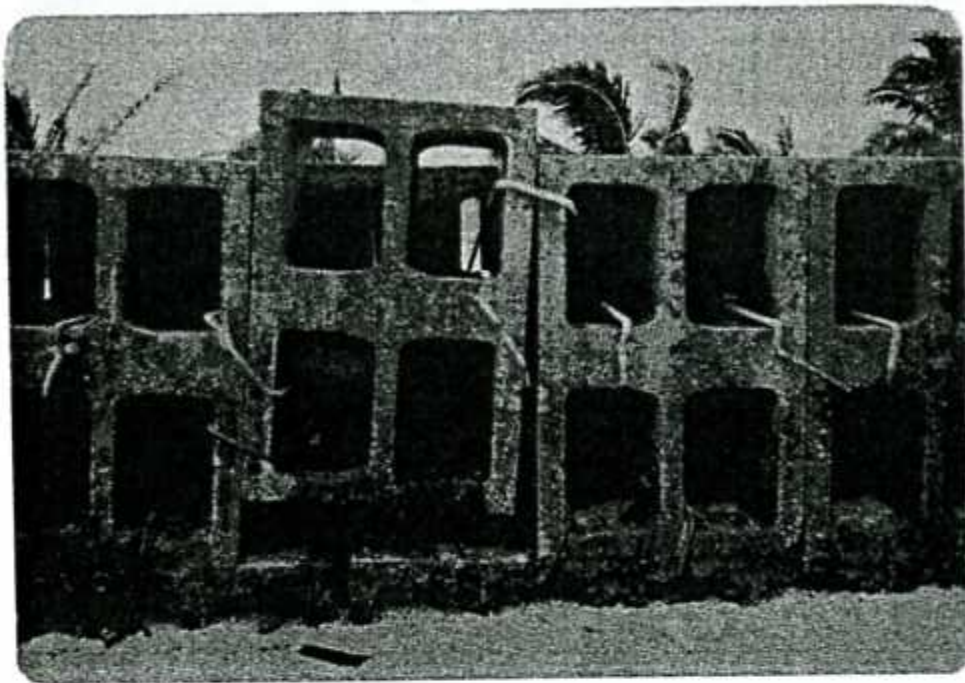
Differential settlement of individual blocks continued over the following 18 months. Although the tie rods were loosening and many of the blocks on the seaward face broke, the structure ceased to rotate. By January 1979, four blocks had been damaged--two near the south end were vertically displaced, and two near the center of the structure had broken away (Figs. 2-603 and 2-604). By May 1979 most of the tie rods were rusted and loose, and in November 1979 several blocks in the seaward face were broken apart (Figs. 2-605 and 2-606). Despite this component damage, the Sandgrabber remained functionally effective.

Figure 2-603. Vertically displaced block toward the south end of the structure, Kualoa, Hawaii, 4 January 1979.

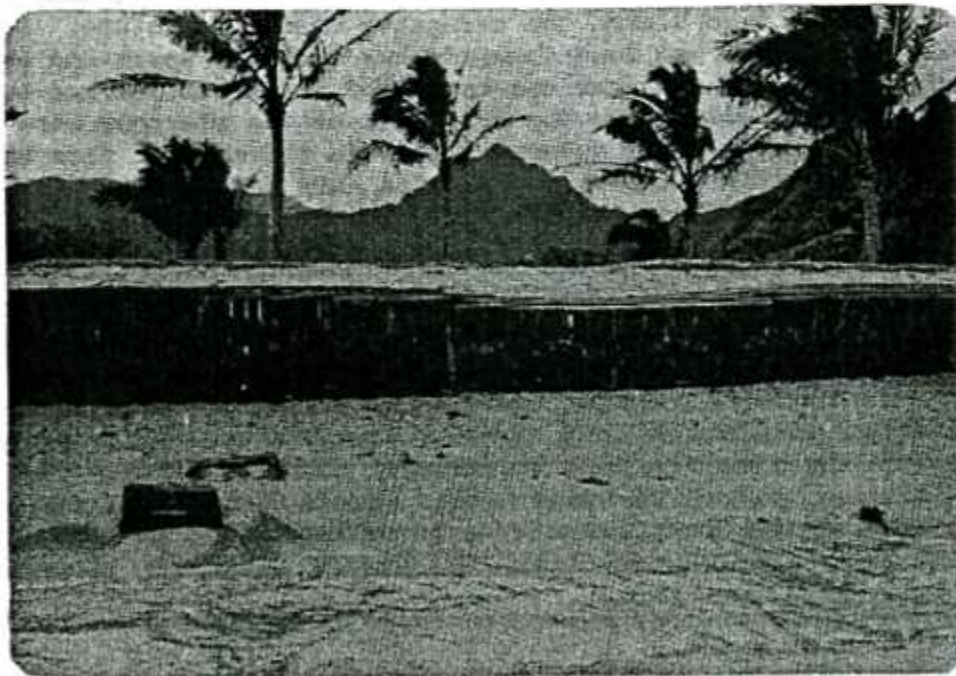
Figure 2-604. Displaced blocks lying in sand along mid-section of the structure, Kauloa, Hawaii, 4 January 1979.

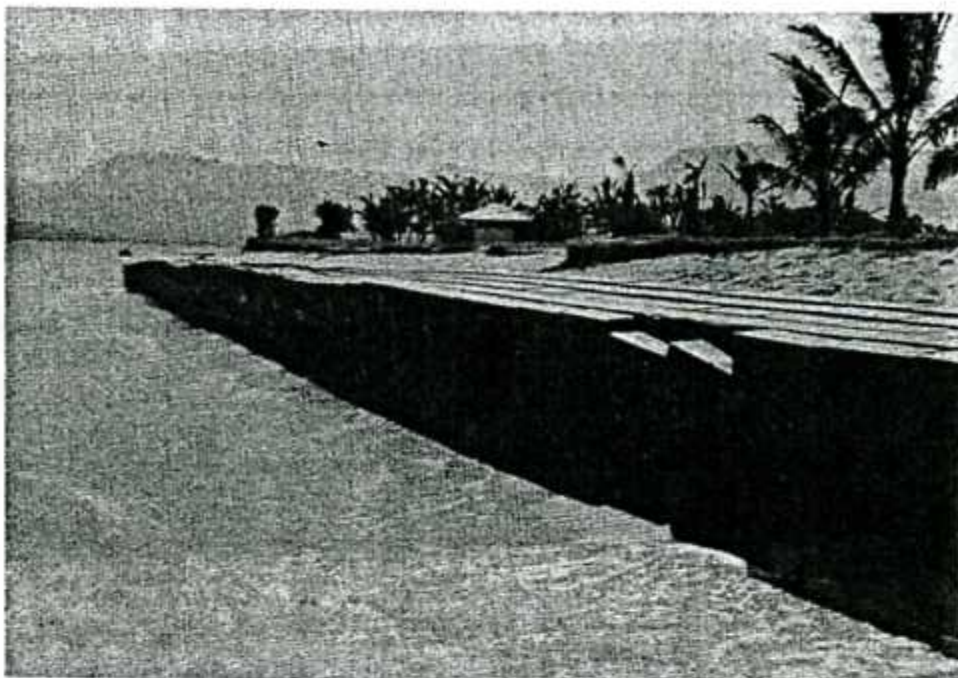
Figure 2-605. Broken blocks viewed from midsection of structure, Kualoa, Hawaii, 8 November 1979.

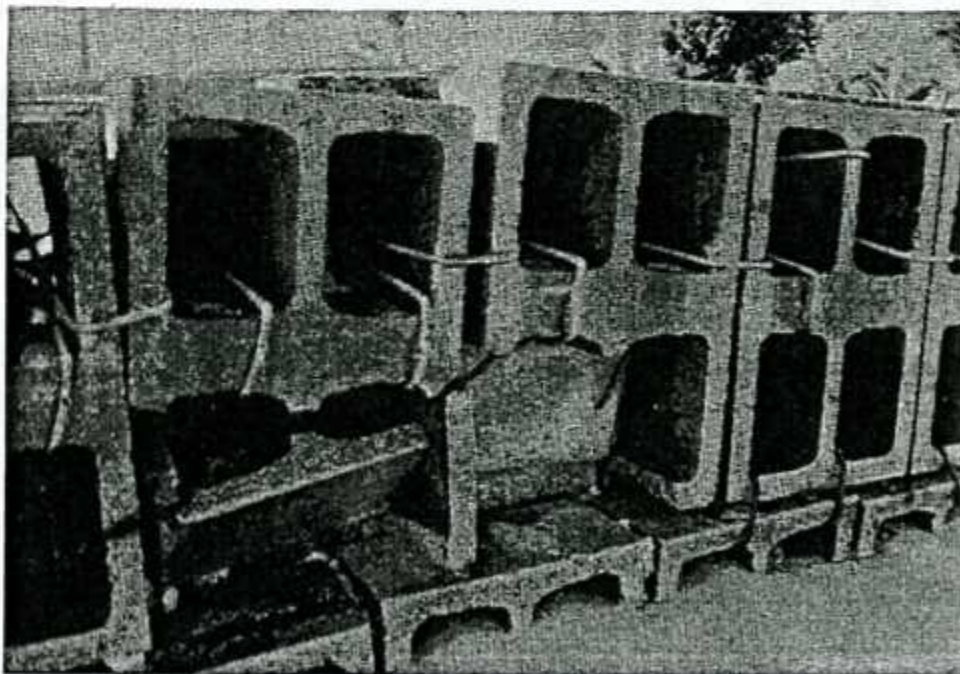
Figure 2-606. Broken blocks near north end of structure, Kualoa, Hawaii, 8 November 1979.

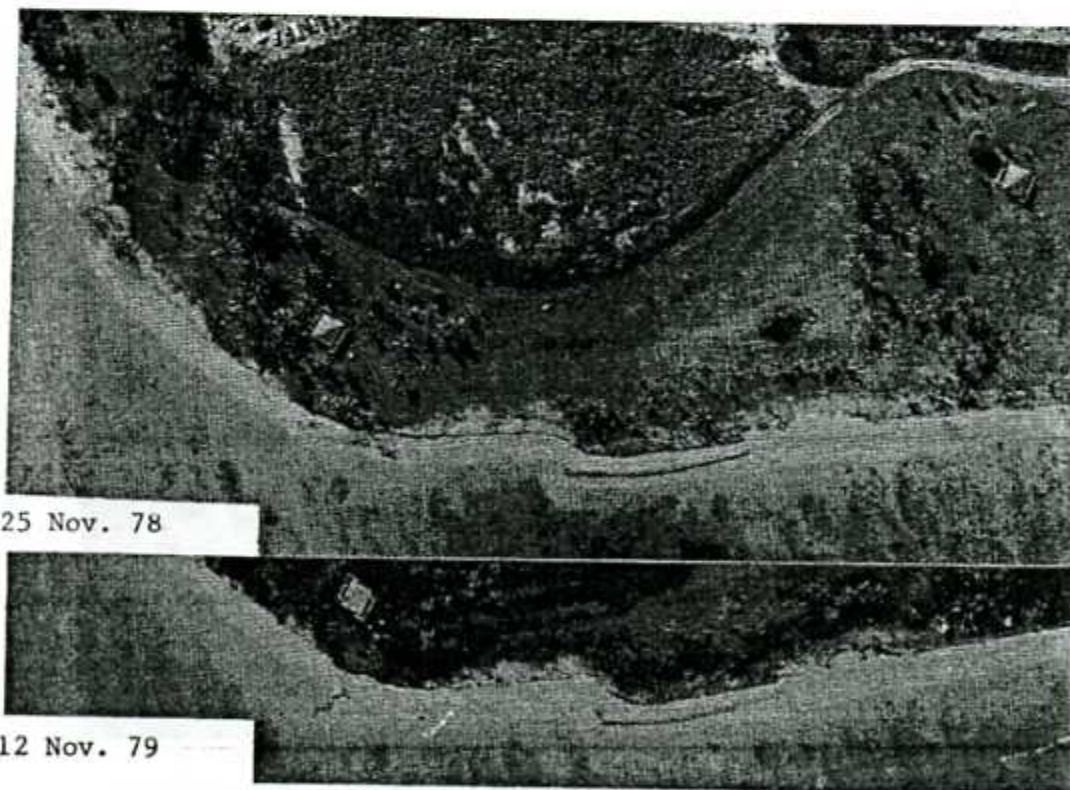
By June 1978, the preliminary effects of the Sandgrabber at the Kualoa site were identified. Sand accumulated on the landside of the structure as expected, but not along the seaward face. The northern and southern beach areas near the Sandgrabber accreted somewhat at first, but erosion of the downdrift bank was accelerated (Fig. 2-607). Between June 1978 and August 1979, erosion of the downdrift bank averaged +1 foot per month. The rate of erosion decreased through November 1979. Figure 2-608 shows the progressive erosion downdrift of the Sandgrabber from November 1978 to November 1979. Between November 1979 and January 1980, +10 feet of downdrift shoreline was lost as a result of winter storms.

Figure 2-608. Progressive erosion south of Sandgrabber, Kualoa, Hawaii, 25 November 1978 and 12 November 1979.

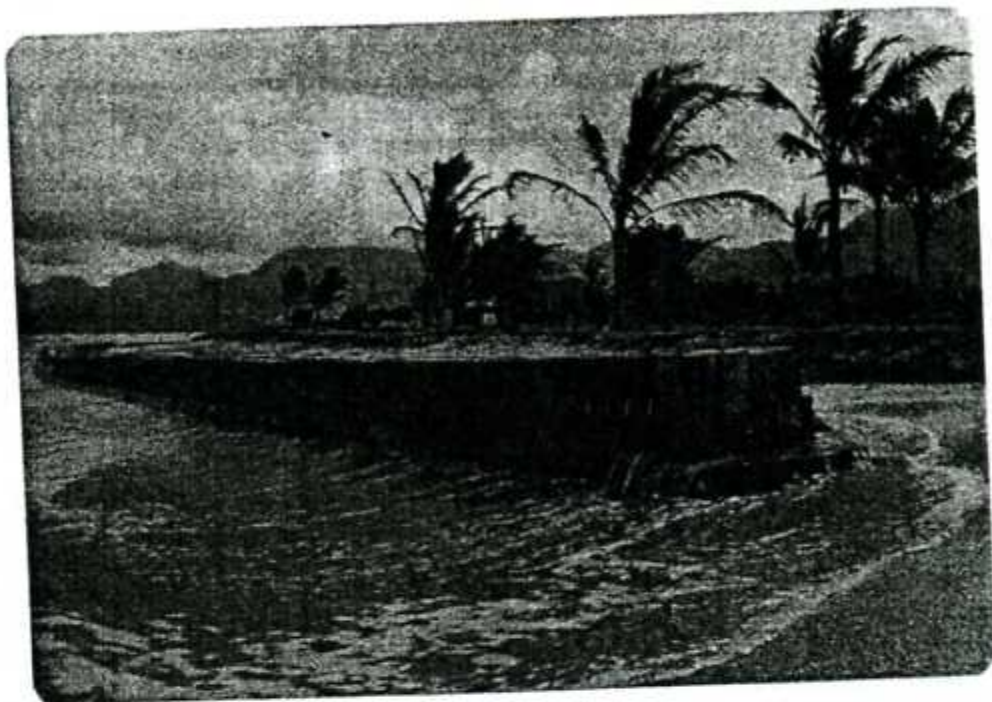
In January 1979, there was slight accretion along the seaward face (compare Figs. 2-609 and 2-610); however, this trend did not continue. Accretion of sand landward of the structure continued until September 1979, when minor scouring along the central segment of the landward face was observed.

Figure 2-609. Seaward face of structure, Kualoa, Hawaii, 19 June 1978.

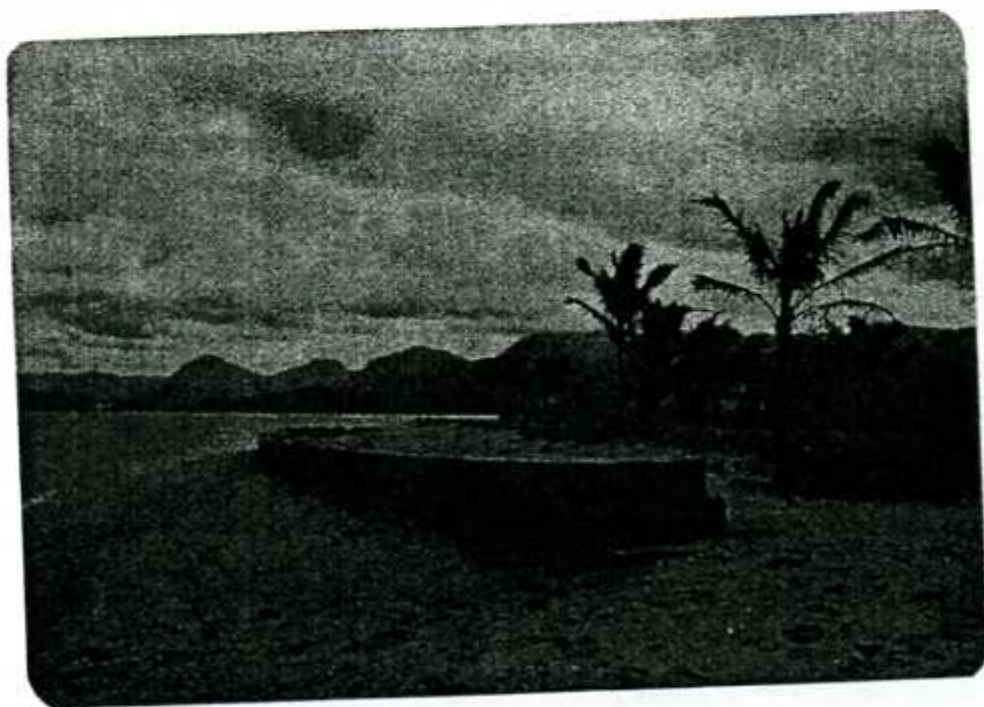
Figure 2-610. Sand accumulation on seaward face of structure, Kualoa, Hawaii, 4 January 1979.
