Figure 2-597. Location map of Kualoa, Hawaii, monitoring site.

(2) Monitoring Project. In late fall of 1977, the Department of Parks and Recreation, City and County of Honolulu, had a contractor install a 200-foot-long Sandgrabber just north of Kualoa Point to test its effectiveness in controlling erosion of the park shoreline. A profile of the device is shown in Figure 2-599. After the structure was completed on 5 December 1977, the Department conducted a 2-month study of its performance.

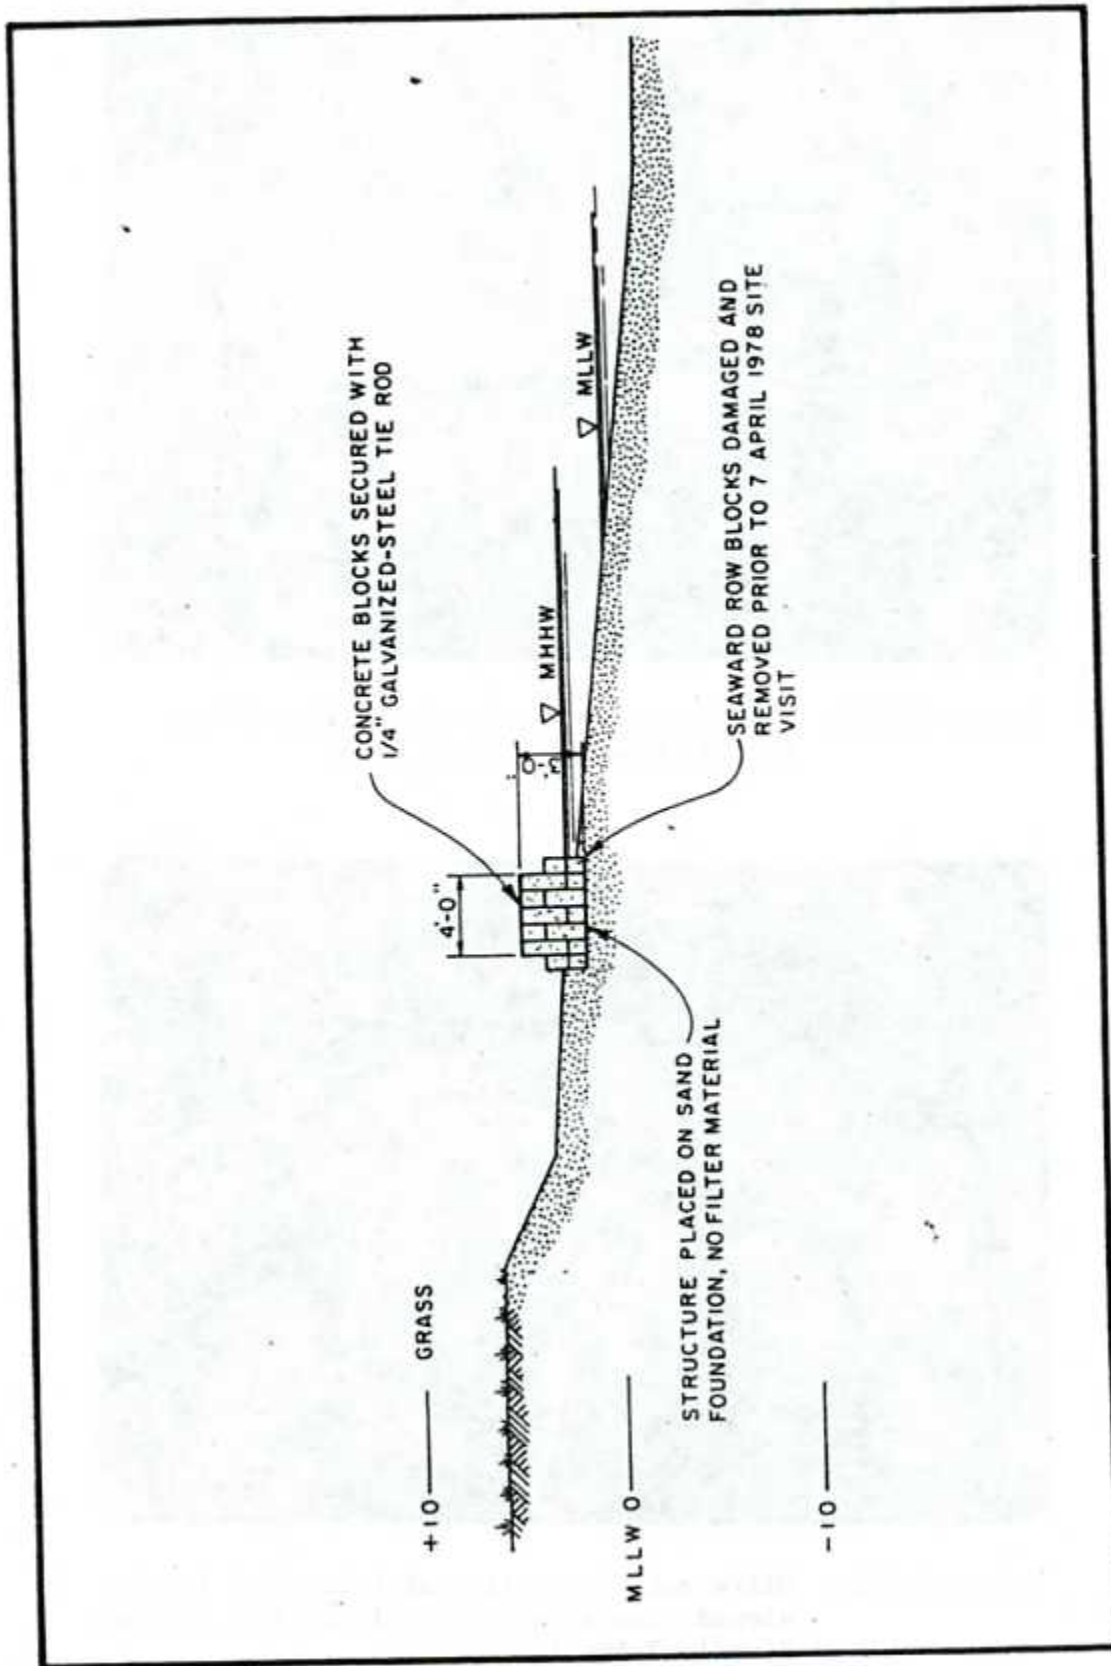
Figure 2-599. Sandgrabber profile at Kualoa site.

Two problems became apparent almost immediately. The seaward course of blocks consisted largely of red cinder blocks, of a lighter consistency than the blocks used for the main body of the structure. By 26 December 1977, most of these blocks had broken under the effects of wave action, and the structure seemed to be gradually working itself apart. Shortly thereafter, the contractor removed the broken blocks along with the entire seaward course and retightened the loose tie rods. This restored the structural integrity of the Sandgrabber. The second problem which became apparent was that the south end of the Sandgrabber was not curved far enough toward the beach berm to prevent wave attack on the back side of the structure. This southeasterly wave attack was not expected. Aerial photos indicate that it was caused by diffraction of the northeast trade waves around Mokolii Island, and subsequent refraction over the reef. When this occurred, the waves eroded the sand from behind the south end of the Sandgrabber. A protective extension was added to the south end; however, even this extension did not completely solve the problem of wave attack from the southeast. There was continuing evidence that waves were getting in behind the structure.

By the end of the 2-month study, the structure had settled approximately 1 foot into the sand along a 10-foot reach at the south end and along a 15-foot reach near the center. The structure remained intact, and there was a smooth transition from the slumped areas to the rest of the Sandgrabber. Approximately 148 cubic yards of sand accreted both behind and seaward of the structure along its 200-foot length. This was estimated to be about 15 percent of the material available in the littoral transport system. Severe erosion occurred downstream of the structure, extending for a distance of 300 feet. Although the Sandgrabber contributed somewhat to the erosion by retarding littoral transport past the site, it appeared that larger waves than normal, combined with high tides, caused most of the erosion.
