(2) Monitoring Project. In late fall of 1977, the Department of Parks and Recreation, City and County of Honolulu, had a contractor install a 200-foot-long Sandgrabber just north of Kualoa Point to test its effectiveness in controlling erosion of the park shoreline. A profile of the device is shown in Figure 2-599. After the structure was completed on 5 December 1977, the Department conducted a 2-month study of its performance.

(3) Performance. Overall, the Sandgrabber remained structurally sound throughout the monitoring period. Differential settlement along its midsection, and of individual blocks, was observed in April 1978 (Figs. 2-600 and 2-601). The entire structure was also rotating downward on the seaward side. The short section on the south end had a seaward slope of 13° (Fig. 2-602). By May, although this short section had continued to settle, the seaward slope was only 8°.

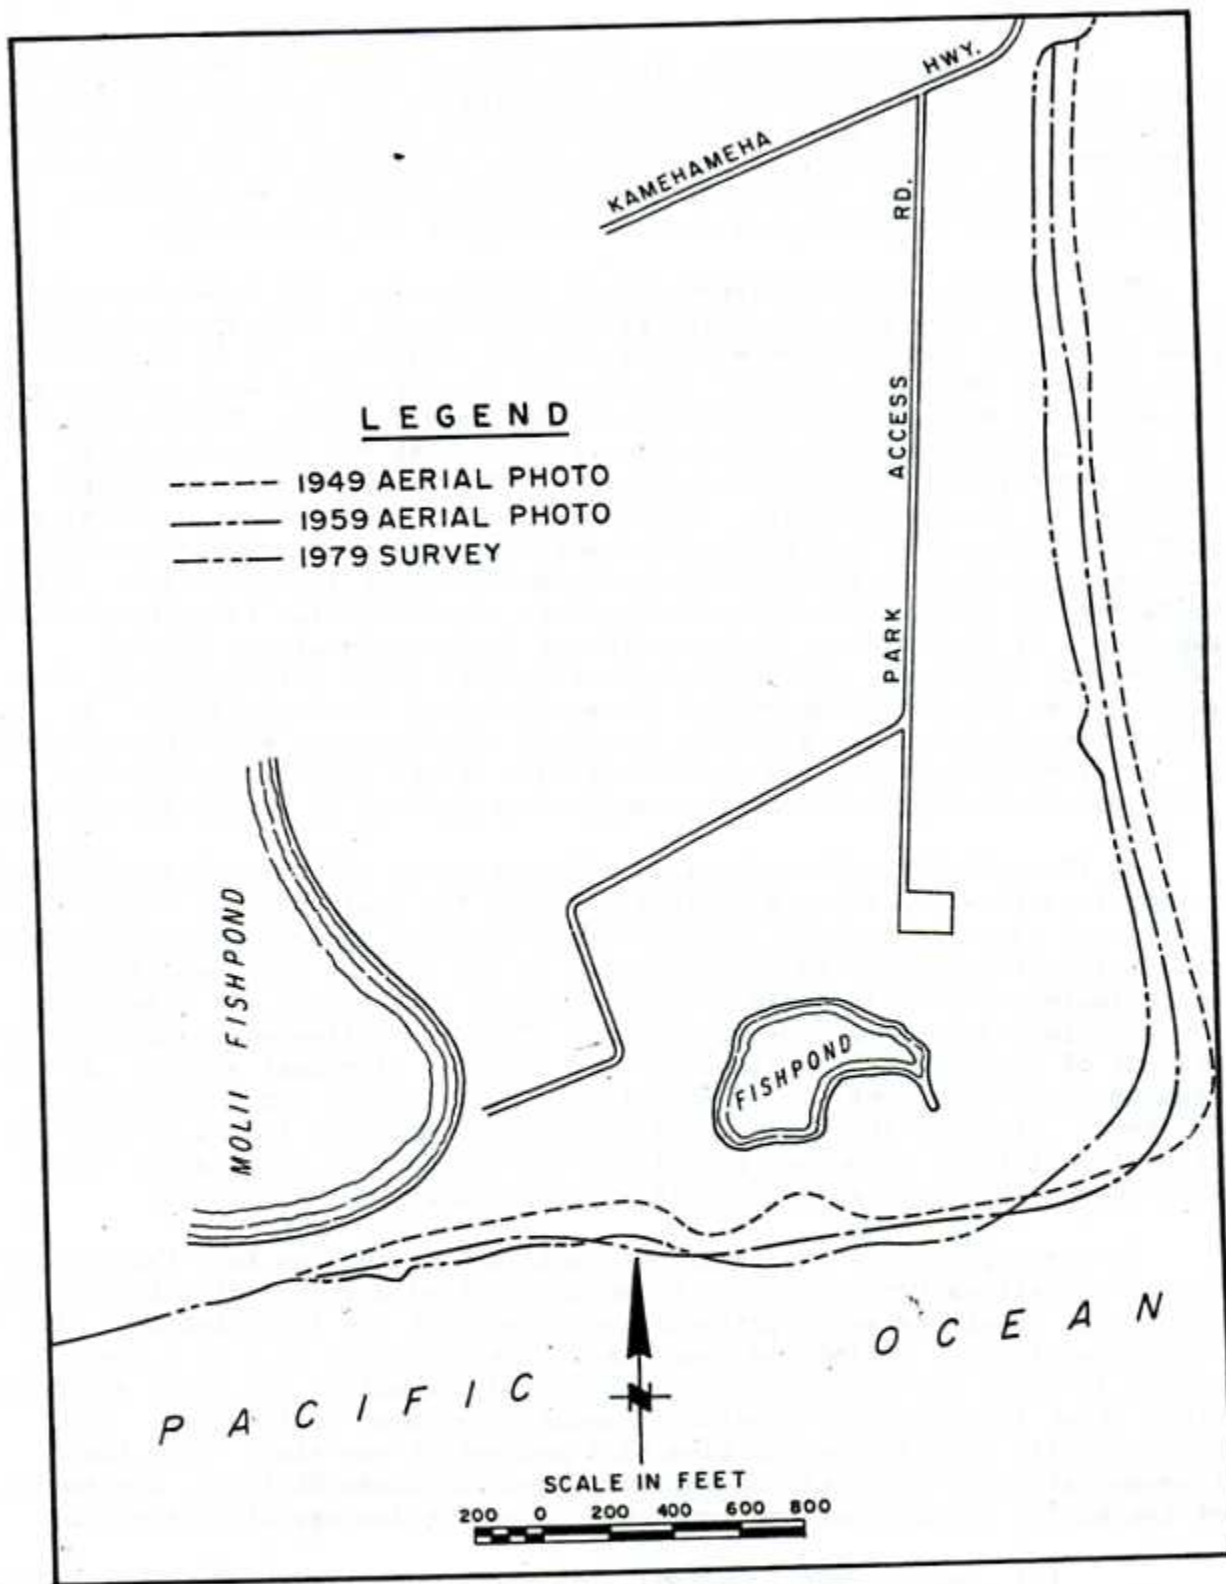
(d) The Problem. The eastern beach at Kualoa Regional Park has undergone continuous erosion. Resulting shoreline changes are shown in Figure 2-598. The average annual loss of sand from the eastern beach area from 1949 to 1975 was 4,800 cubic yards. During this period, the eastern shoreline had receded at an average rate of about 4 feet per year, and the shoreline near Kualoa Point had receded at about 7 feet per year. Although most of the park's southern shoreline accreted during 1949-75, there was a net loss of 80,000 cubic yards for the whole park. This represents more than 6 acres of parklands lost. Studies have indicated that, from 1949 to 1975, 30,000 cubic yards of sand was lost from the littoral system at Kualoa, probably to the offshore sand deposit south of Moli'i Fishpond. Beach erosion appears almost continuous during trade-wind conditions, and a period of higher than normal tides under typical trade-wind conditions can accelerate shoreline erosion.

Figure 2-598. Shoreline changes at Kualoa Park.

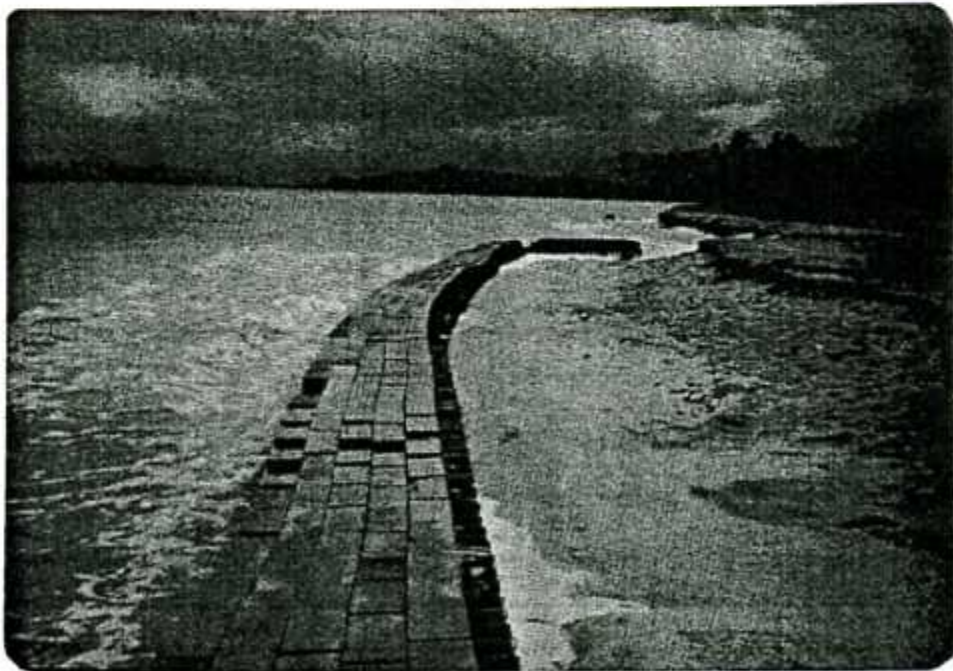
Figure 2-601. Differential settling of individual blocks viewed from structure's midsection, Kualoa, Hawaii, 7 April 1978.

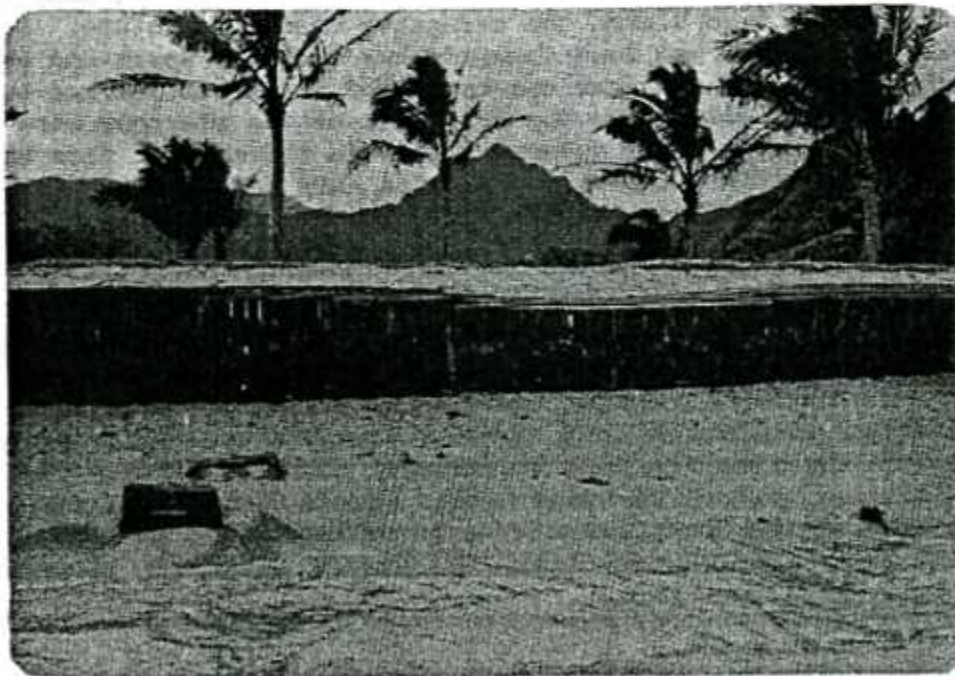
Differential settlement of individual blocks continued over the following 18 months. Although the tie rods were loosening and many of the blocks on the seaward face broke, the structure ceased to rotate. By January 1979, four blocks had been damaged--two near the south end were vertically displaced, and two near the center of the structure had broken away (Figs. 2-603 and 2-604). By May 1979 most of the tie rods were rusted and loose, and in November 1979 several blocks in the seaward face were broken apart (Figs. 2-605 and 2-606). Despite this component damage, the Sandgrabber remained functionally effective.

Figure 2-604. Displaced blocks lying in sand along mid-section of the structure, Kauloa, Hawaii, 4 January 1979.

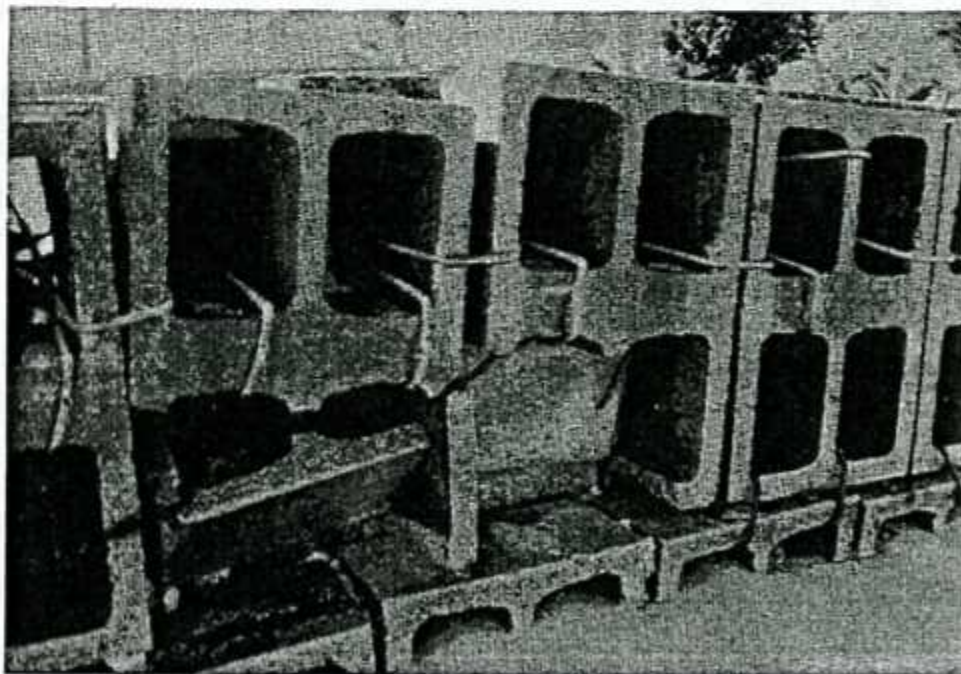
Figure 2-606. Broken blocks near north end of structure, Kualoa, Hawaii, 8 November 1979.

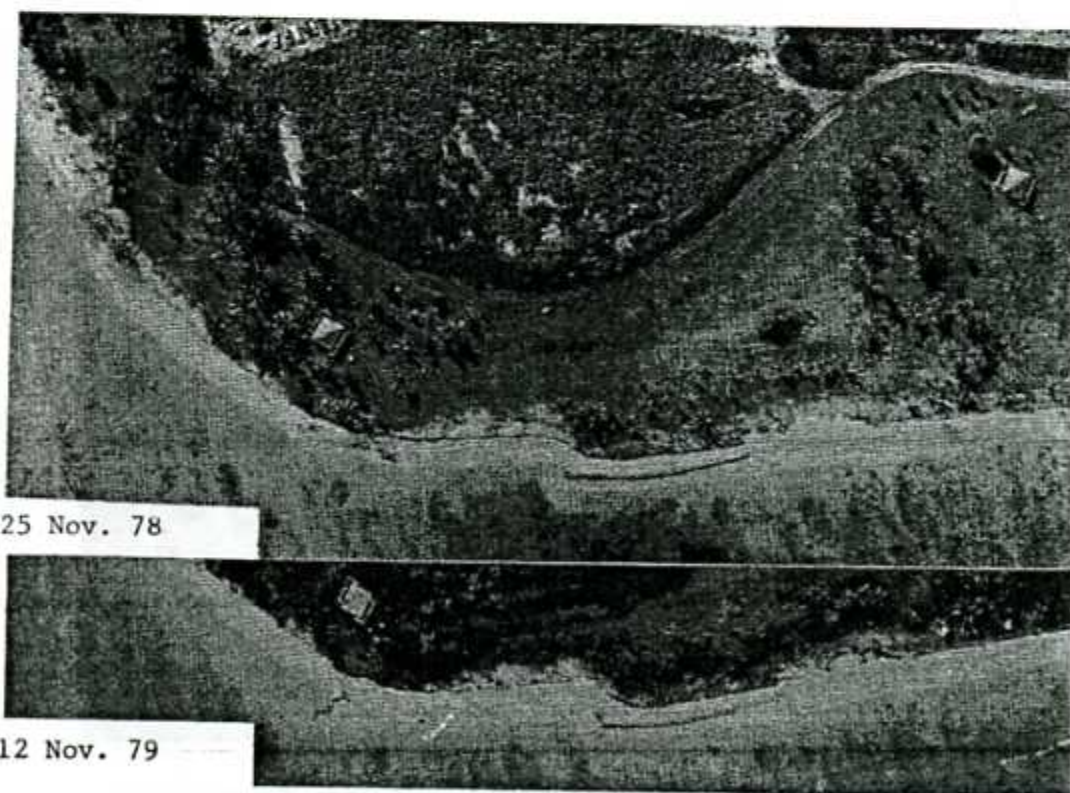
By June 1978, the preliminary effects of the Sandgrabber at the Kualoa site were identified. Sand accumulated on the landside of the structure as expected, but not along the seaward face. The northern and southern beach areas near the Sandgrabber accreted somewhat at first, but erosion of the downdrift bank was accelerated (Fig. 2-607). Between June 1978 and August 1979, erosion of the downdrift bank averaged +1 foot per month. The rate of erosion decreased through November 1979. Figure 2-608 shows the progressive erosion downdrift of the Sandgrabber from November 1978 to November 1979. Between November 1979 and January 1980, +10 feet of downdrift shoreline was lost as a result of winter storms.

Figure 2-608. Progressive erosion south of Sandgrabber, Kualoa, Hawaii, 25 November 1978 and 12 November 1979.

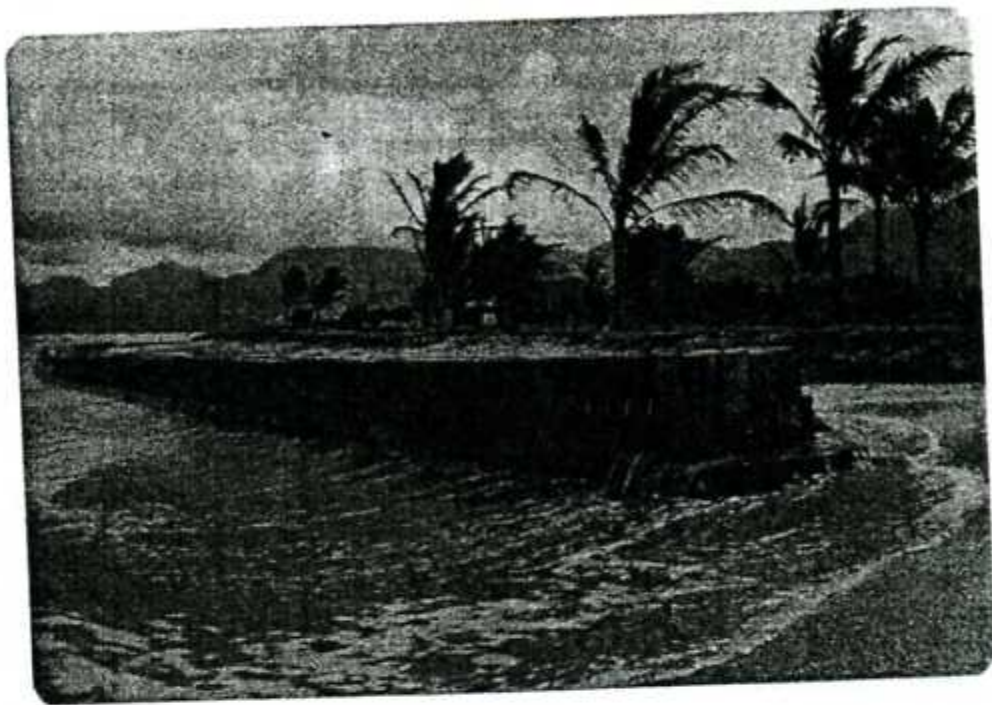
In January 1979, there was slight accretion along the seaward face (compare Figs. 2-609 and 2-610); however, this trend did not continue. Accretion of sand landward of the structure continued until September 1979, when minor scouring along the central segment of the landward face was observed.

Figure 2-609. Seaward face of structure, Kualoa, Hawaii, 19 June 1978.

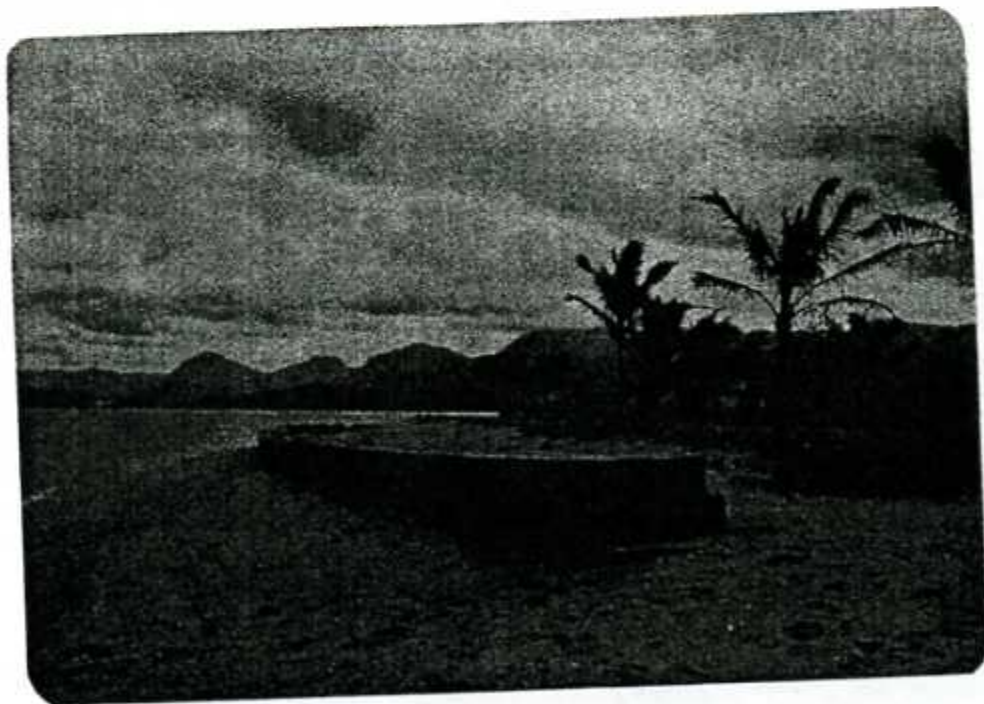
Figure 2-610. Sand accumulation on seaward face of structure, Kualoa, Hawaii, 4 January 1979.
