**FINAL REPORT FOR THE  
SANDGRABBER DEMONSTRATION PROJECT  
GRAND ISLE, LOUISIANA**

Louisiana Department of Natural Resources  
Coastal Restoration Division  
P.O. Box 94396  
Baton Rouge, La. 70804-9396

February 16, 1995

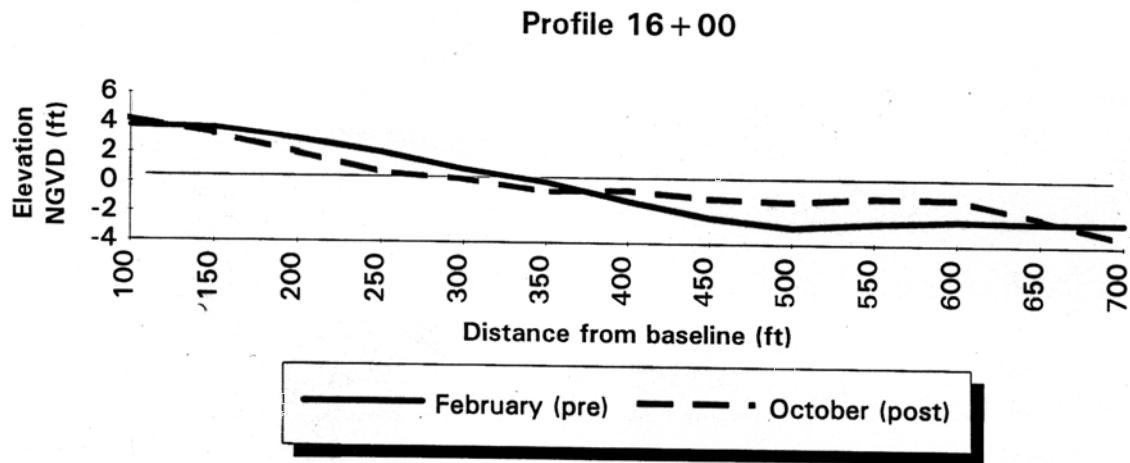
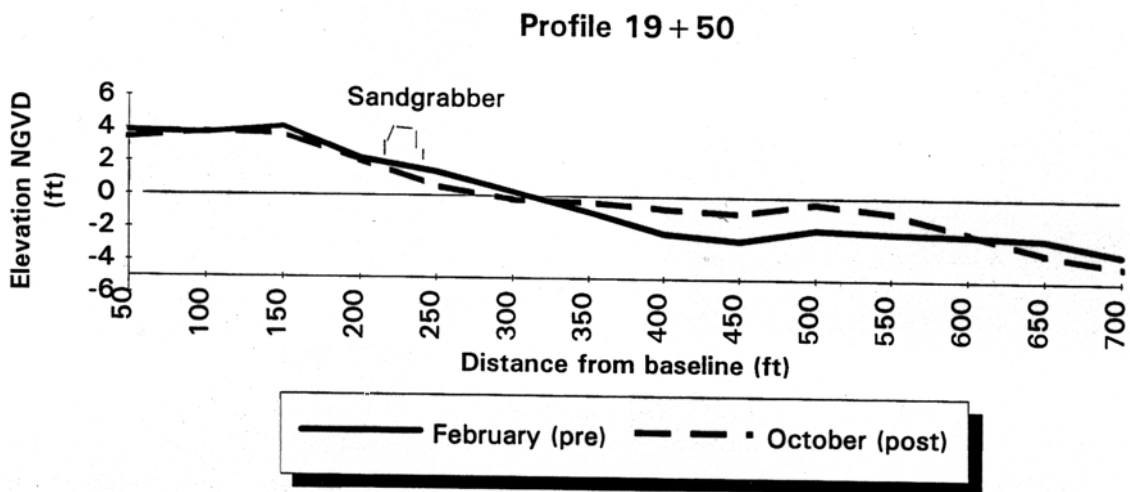
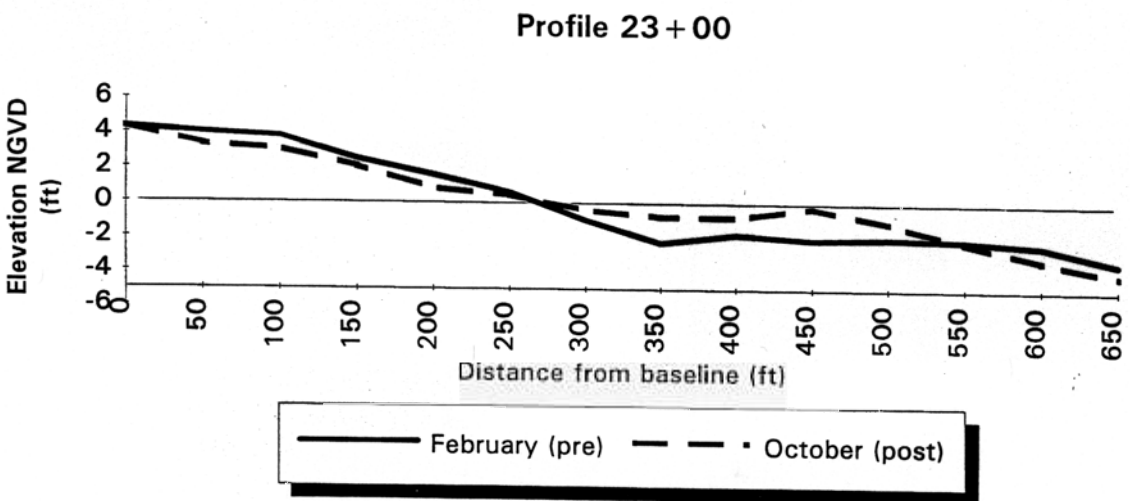
Elevational profiles were originally planned to include four time intervals: prior to construction, 1 mo after construction, 6 mos after construction, and 1 yr after construction. Due to failure of the structure after 10 mos, only two surveys were used to evaluate project performance, February and October 1994. Profiles were run at the structure and for 500 ft on each side of the outermost point of each end of the structure. A total of 31 profiles spaced 50 ft apart with elevations taken at 20-ft centers were surveyed on each profile line. All elevations were referenced to NGVD (figure 4). Due to the failure and subsequent removal of the project, only intensive field observation reports and comparison between two field surveys will be used to describe project performance. Elevational changes determined by T. Baker Smith and Son, Inc., show minimal accretion in the project area; accretion is well offshore and extends both east and west of the project (figure 5). In the areas surrounding the Sandgrabber structure, little accretion had accumulated.

**Figure 5.** Examples of survey data taken pre/post construction downdrift (16+00), centerline (19+50), and updrift of the structure(23+00).

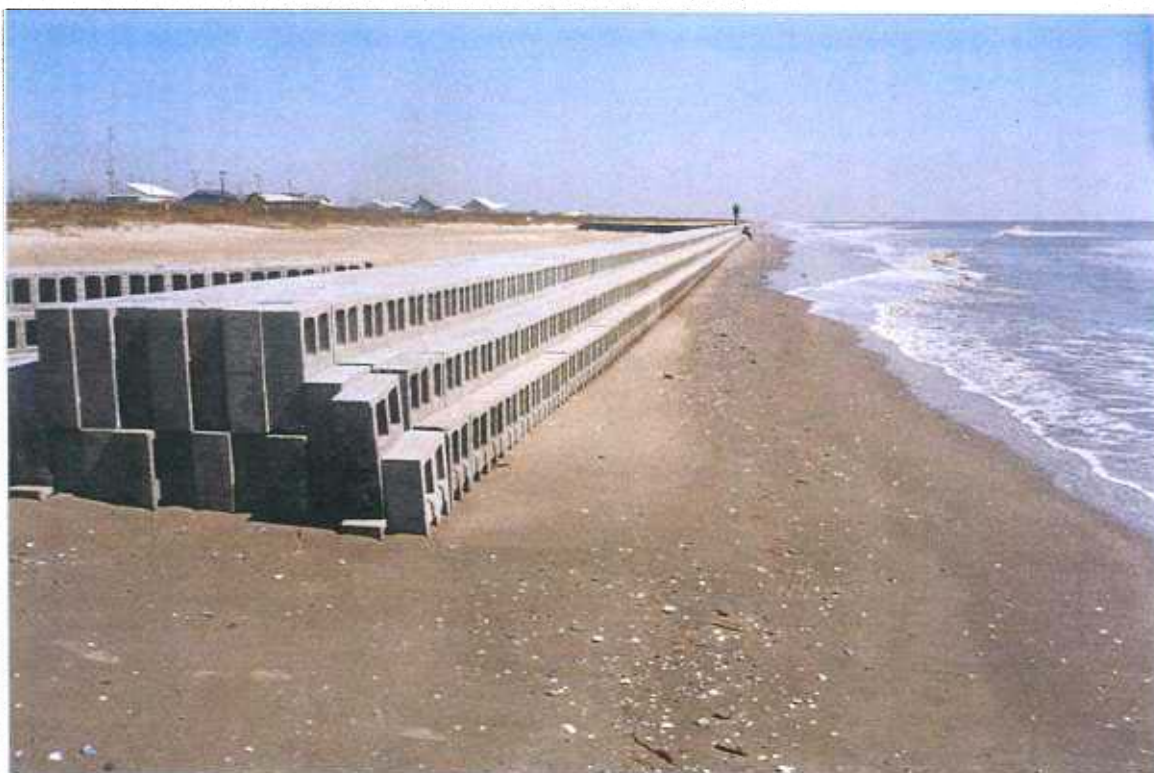
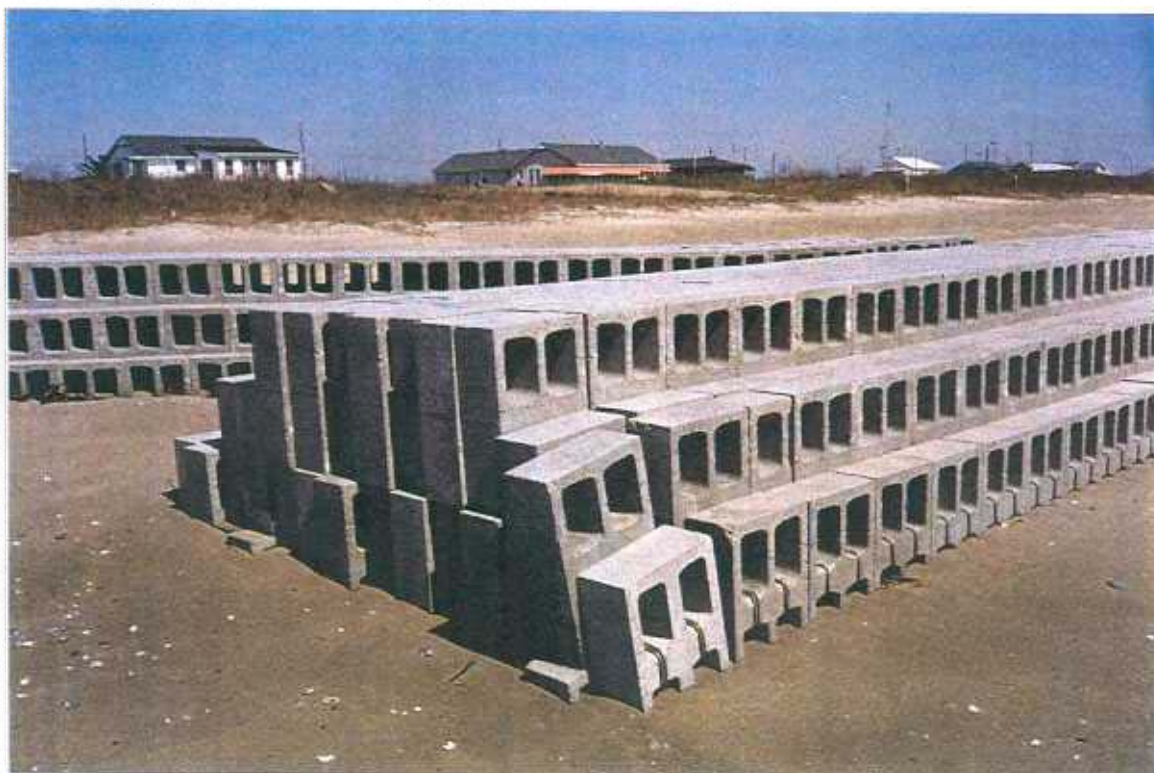
| <b>2/8/94</b> | Accretion behind the structure was noted, some minor settlement along the west end of the structure had occurred (figure 6). |

**Figure 6.** Some accretion and settlement on the west end.

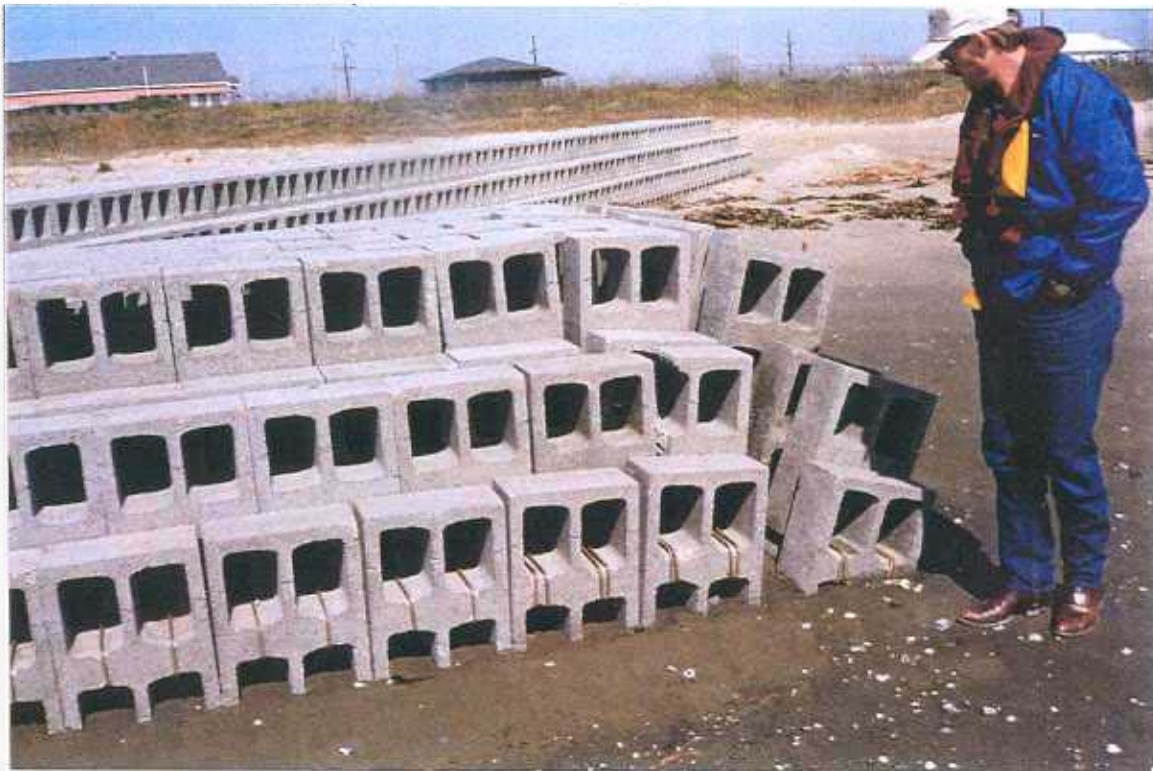
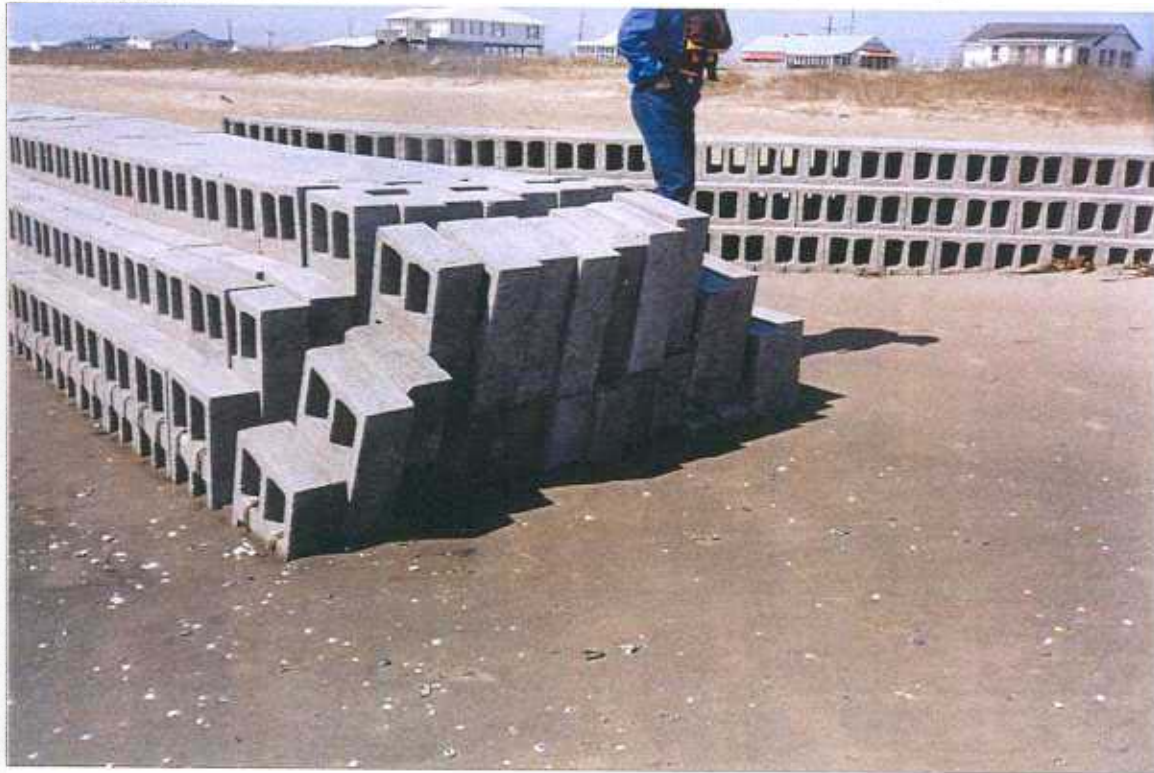
| <b>3/3/94</b> | Settlement of the structure has now occurred on both east and west ends; significant settlement and displacement of the concrete masonry units at the east end (figure 7). |

**Figure 7.** Settlement along the east end of the structure.

| <b>3/25/94</b> | Settlement repairs completed on east and west ends. |
