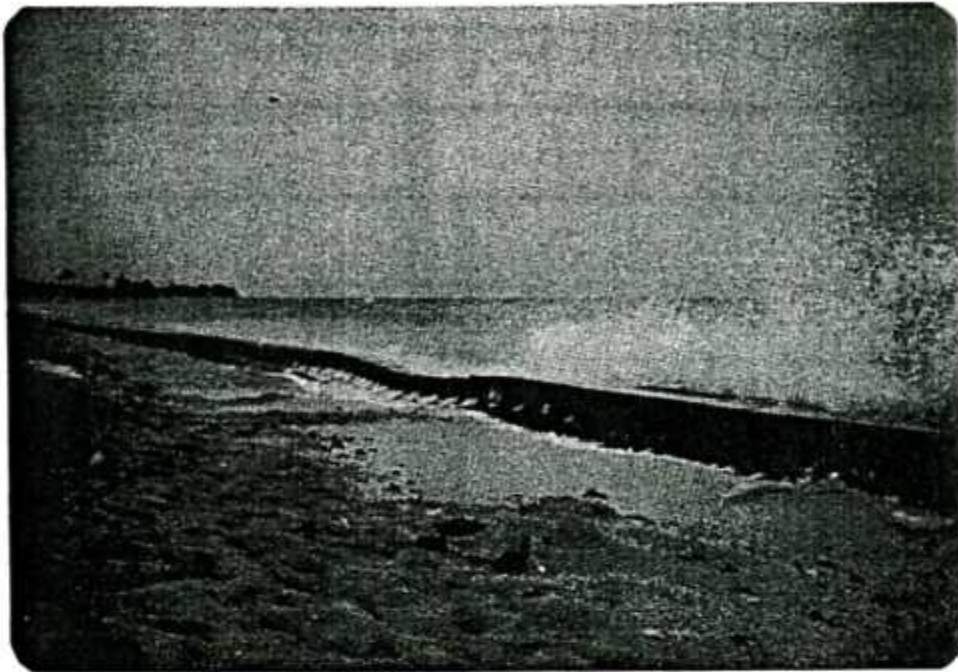
(3) Performance. Overall, the Sandgrabber remained structurally sound throughout the monitoring period. Differential settlement along its midsection, and of individual blocks, was observed in April 1978 (Figs. 2-600 and 2-601). The entire structure was also rotating downward on the seaward side. The short section on the south end had a seaward slope of 13° (Fig. 2-602). By May, although this short section had continued to settle, the seaward slope was only 8°.

Figure 2-600. Settlement of blocks along midsection, Kualoa, Hawaii, 7 April 1978.

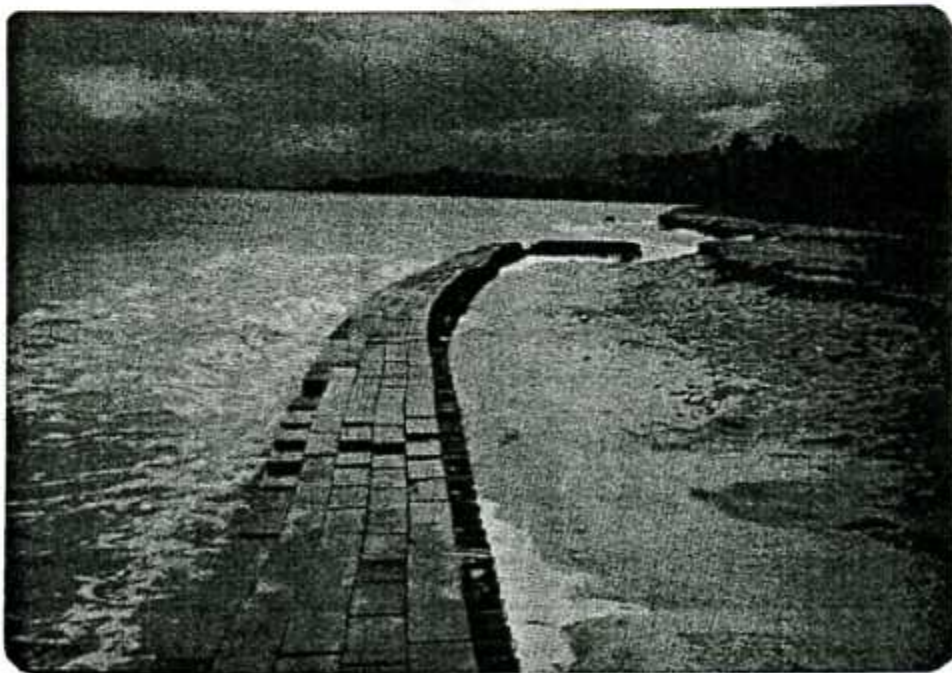
Figure 2-601. Differential settling of individual blocks viewed from structure's midsection, Kualoa, Hawaii, 7 April 1978.

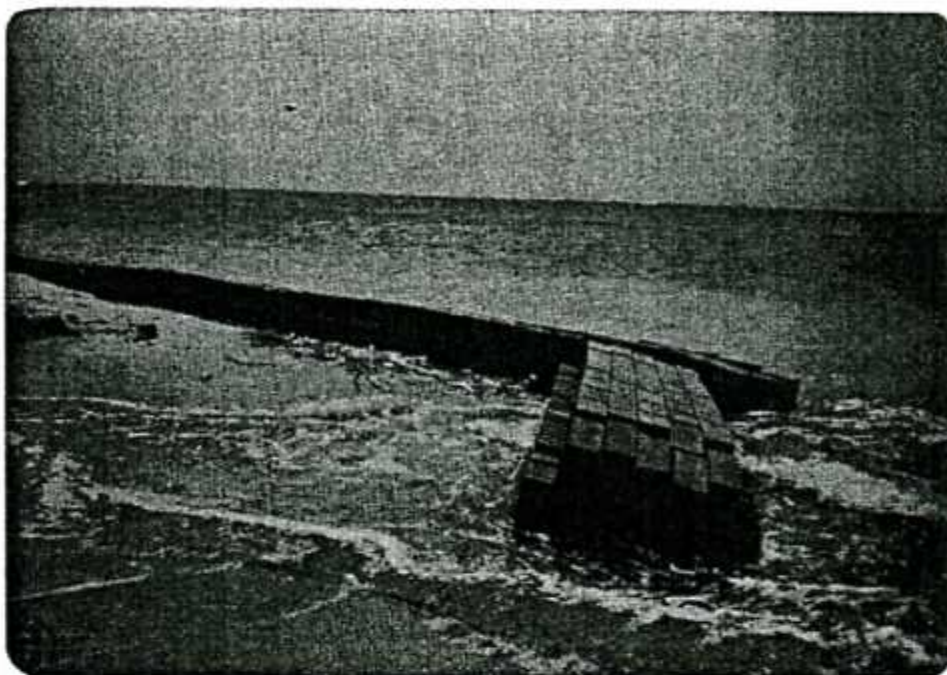
Figure 2-602. Seaward slope of south end of Sandgrabber, Kualoa, Hawaii, 7 April 1978.

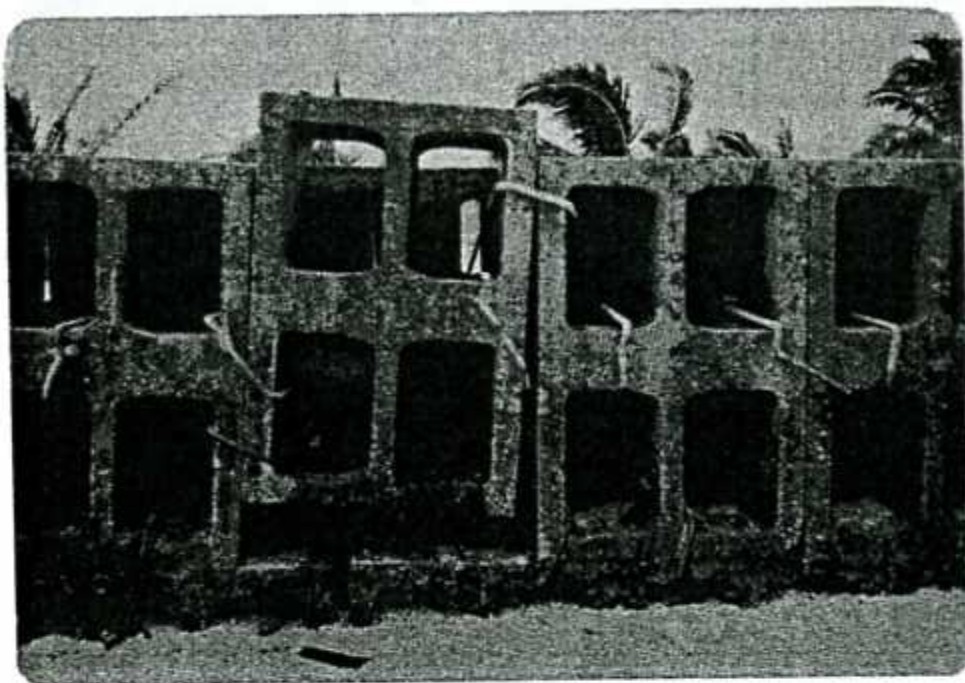
Differential settlement of individual blocks continued over the following 18 months. Although the tie rods were loosening and many of the blocks on the seaward face broke, the structure ceased to rotate. By January 1979, four blocks had been damaged--two near the south end were vertically displaced, and two near the center of the structure had broken away (Figs. 2-603 and 2-604). By May 1979 most of the tie rods were rusted and loose, and in November 1979 several blocks in the seaward face were broken apart (Figs. 2-605 and 2-606). Despite this component damage, the Sandgrabber remained functionally effective.

Figure 2-603. Vertically displaced block toward the south end of the structure, Kualoa, Hawaii, 4 January 1979.

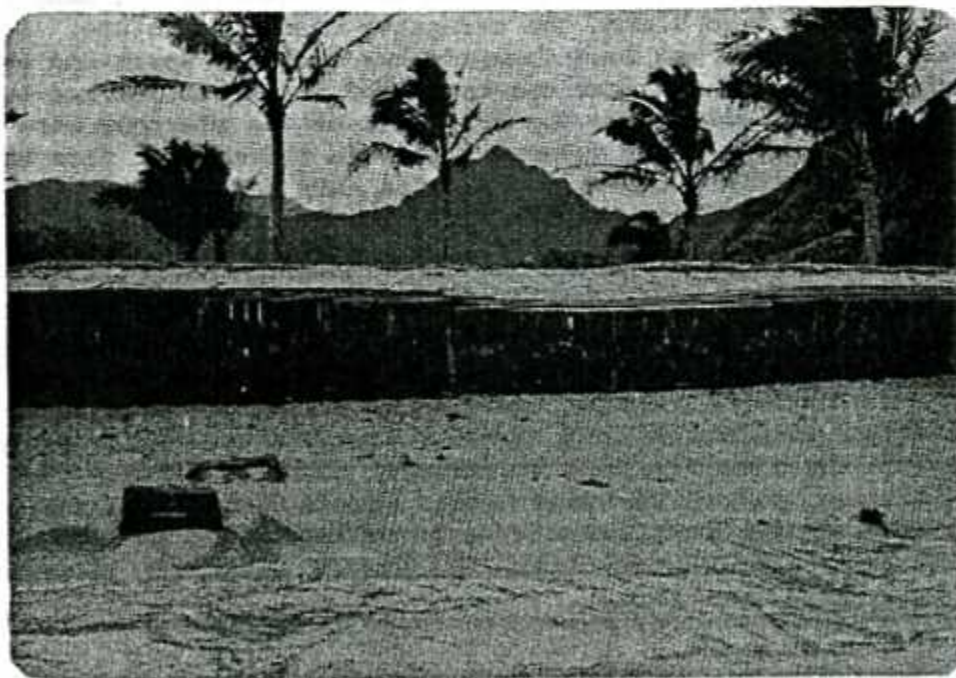
Figure 2-604. Displaced blocks lying in sand along mid-section of the structure, Kauloa, Hawaii, 4 January 1979.

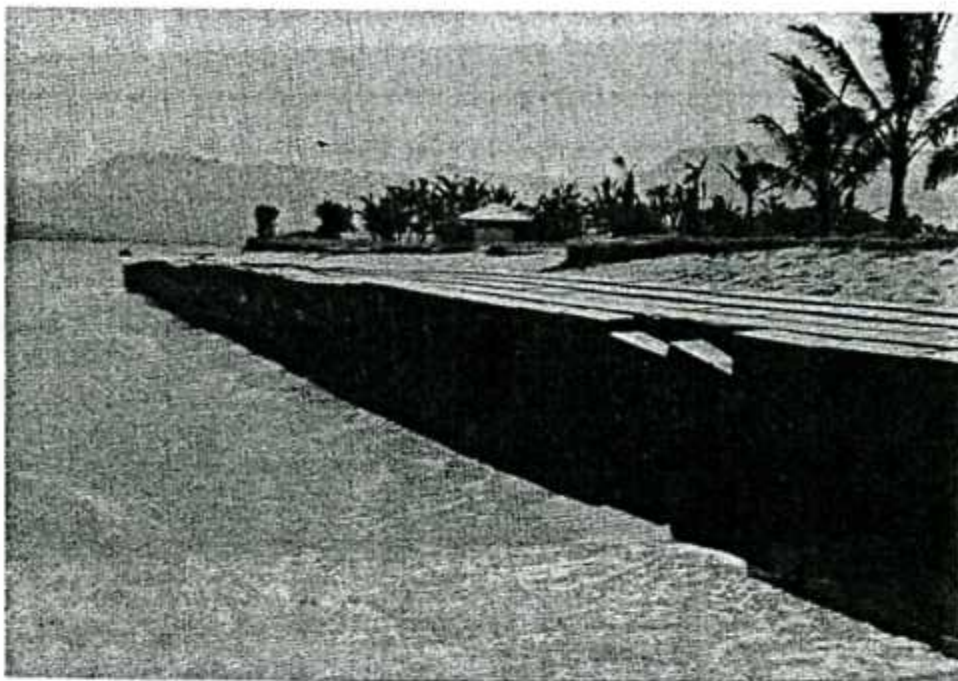
Figure 2-605. Broken blocks viewed from midsection of structure, Kualoa, Hawaii, 8 November 1979.

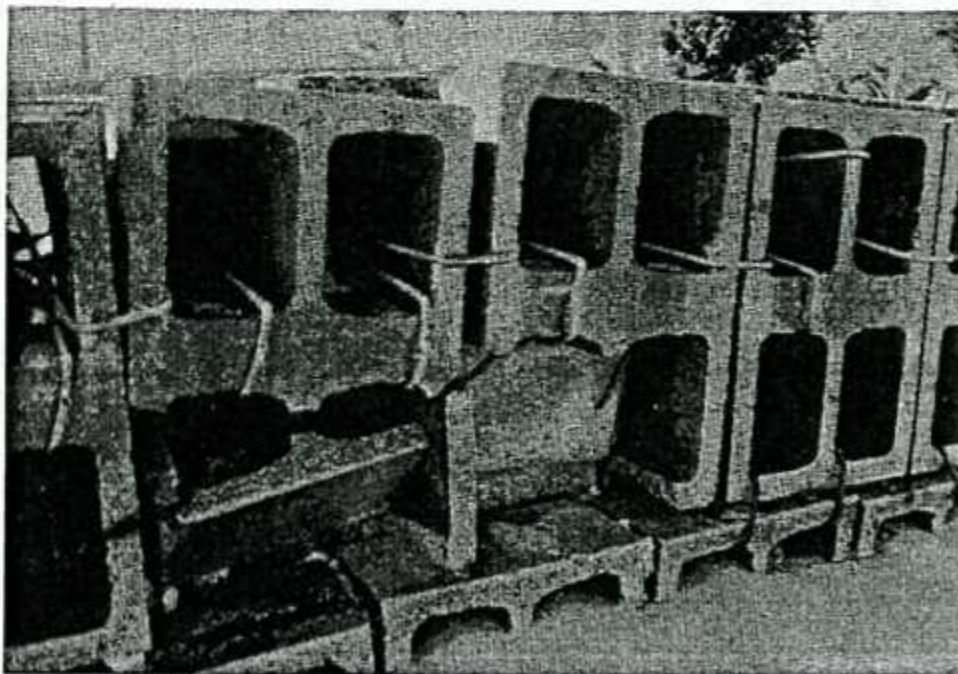
Figure 2-606. Broken blocks near north end of structure, Kualoa, Hawaii, 8 November 1979.

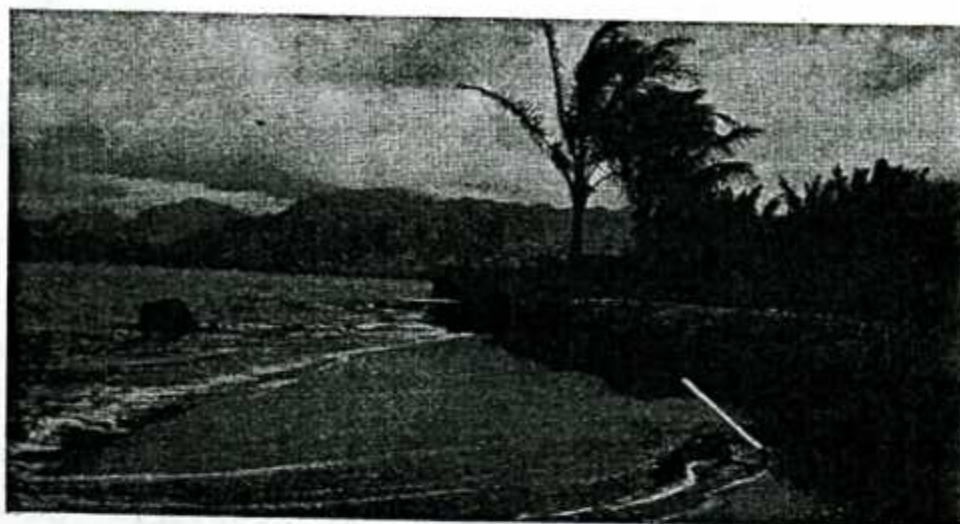
By June 1978, the preliminary effects of the Sandgrabber at the Kualoa site were identified. Sand accumulated on the landside of the structure as expected, but not along the seaward face. The northern and southern beach areas near the Sandgrabber accreted somewhat at first, but erosion of the downdrift bank was accelerated (Fig. 2-607). Between June 1978 and August 1979, erosion of the downdrift bank averaged +1 foot per month. The rate of erosion decreased through November 1979. Figure 2-608 shows the progressive erosion downdrift of the Sandgrabber from November 1978 to November 1979. Between November 1979 and January 1980, +10 feet of downdrift shoreline was lost as a result of winter storms.

Figure 2-607. Erosion of down-drift bank, Kualoa, Hawaii, 19 June 1978.

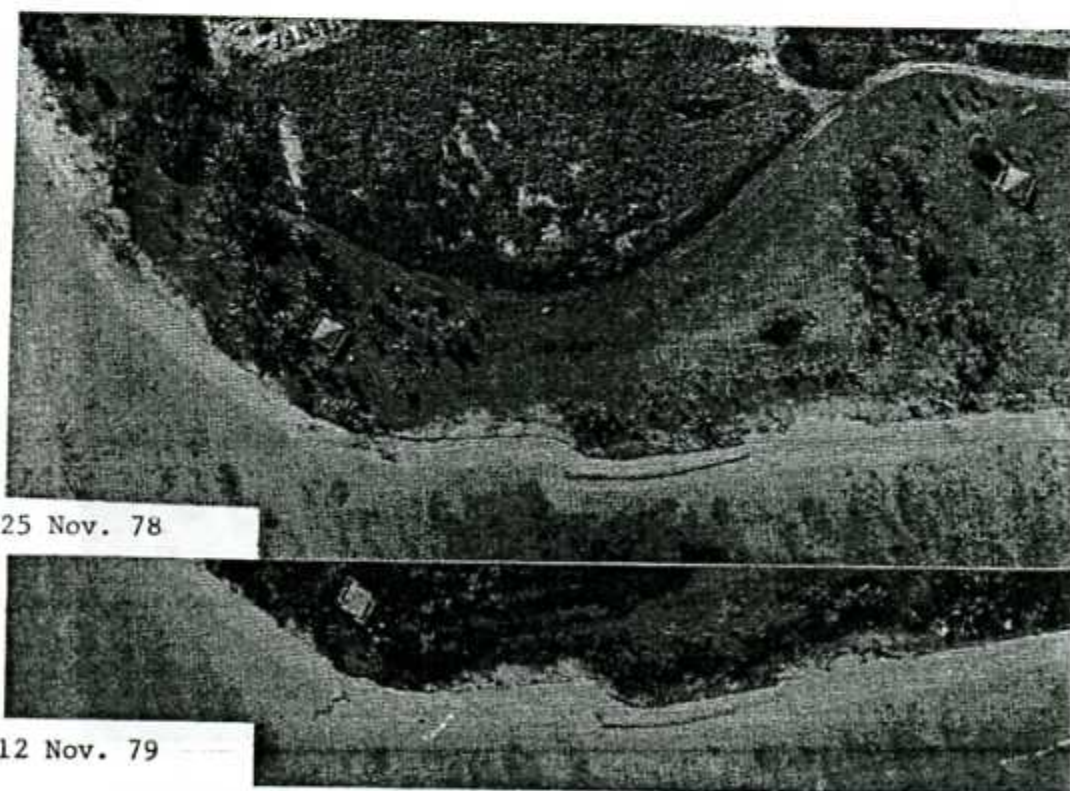
Figure 2-608. Progressive erosion south of Sandgrabber, Kualoa, Hawaii, 25 November 1978 and 12 November 1979.

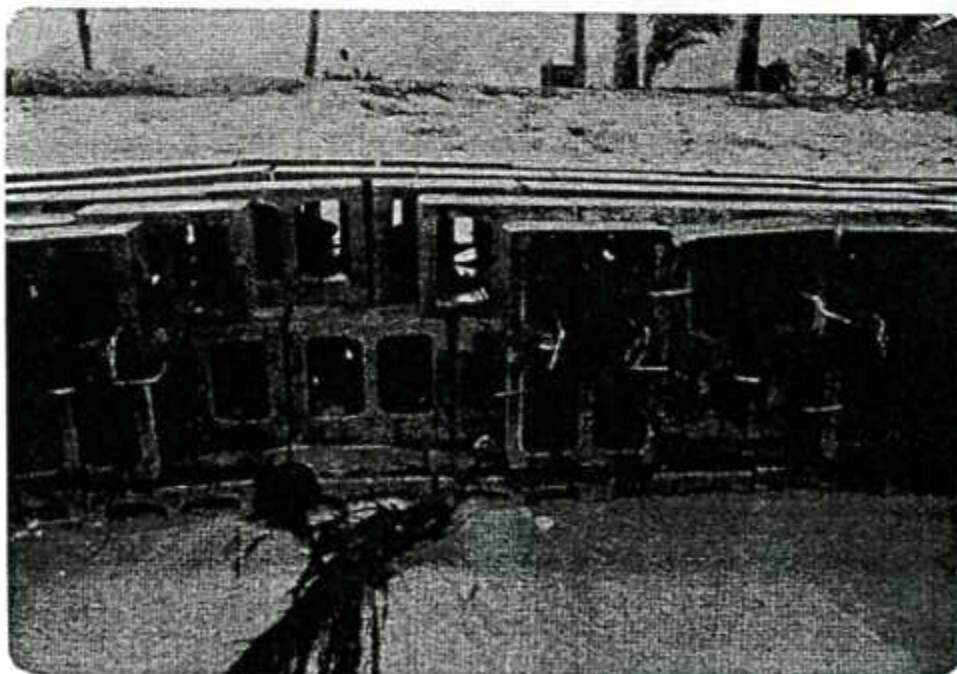
A storm in January 1980 damaged the structure significantly. Four blocks on the landside were broken and 14 were broken on the seaside. Thirteen blocks were missing from the Sandgrabber, five double blocks and eight single blocks from the-seaside. Structural damage was progressive. Typically, the bottom half of the seaward double blocks broke, then the remaining unsupported top half worked loose; the single-block second row from seaward was then exposed and became dislodged (Fig. 2-611). Waves eroded the adjacent beach to the south and flattened the slopes. Continued erosion of the beach to the south has occurred (Figs. 2-612 and 2-613).

The structural integrity of the installation was compromised by differential settlement of the foundation blocks. Some differential settlement is provided for by the tie-rod arrangement, but the allowable limits were exceeded. This resulted in cracked blocks and loosened tie rods, which eventually would hasten structural failure to the extent that the Sandgrabber would no longer function as intended. Two solutions to this problem are suggested: (a) Provide a suitable bedding foundation or initially excavate the foundation to the

Figure 2-611. A damaged section of the Sandgrabber at Kualoa, Hawaii, 17 January 1980.

estimated stable depth and tilt angle, and (b) provide a method of interconnecting the blocks that will allow more differential settlement without compromising the structural integrity of the system.

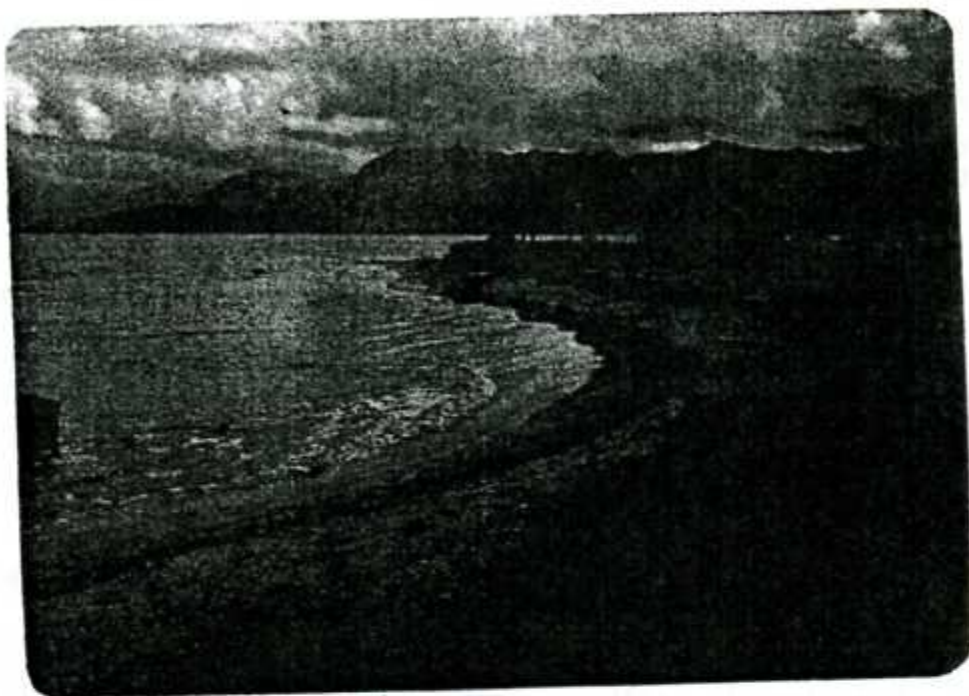
Figure 2-612. The beach south of the structure was eroded by storm waves, Kualoa, Hawaii, 17 January 1980.

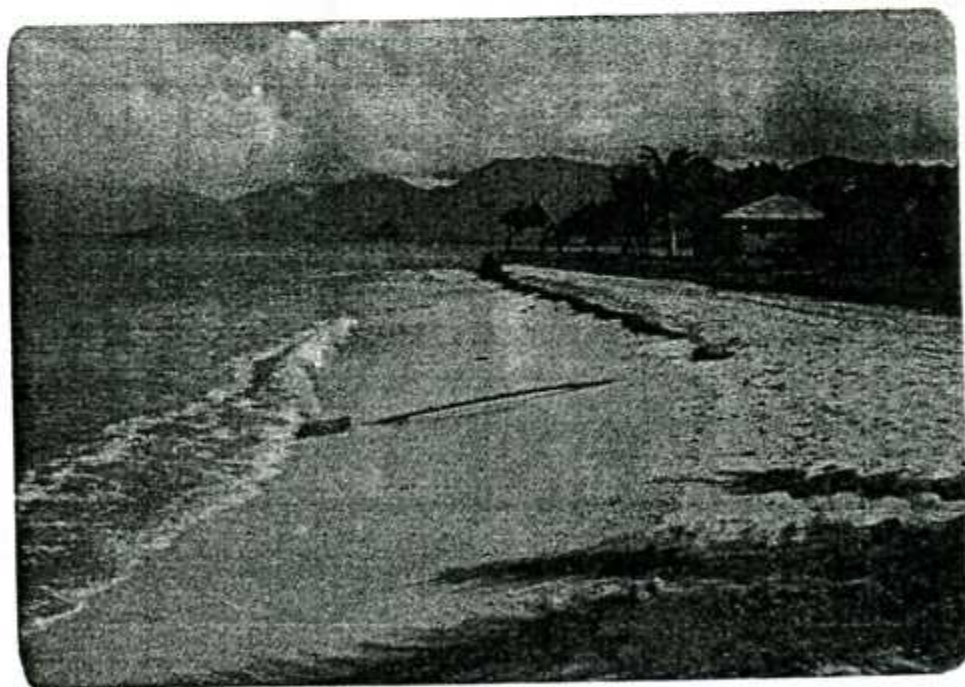
Figure 2-613. Continued erosion of the beach south of the structure, Kualoa, Hawaii, 29 May 1980.

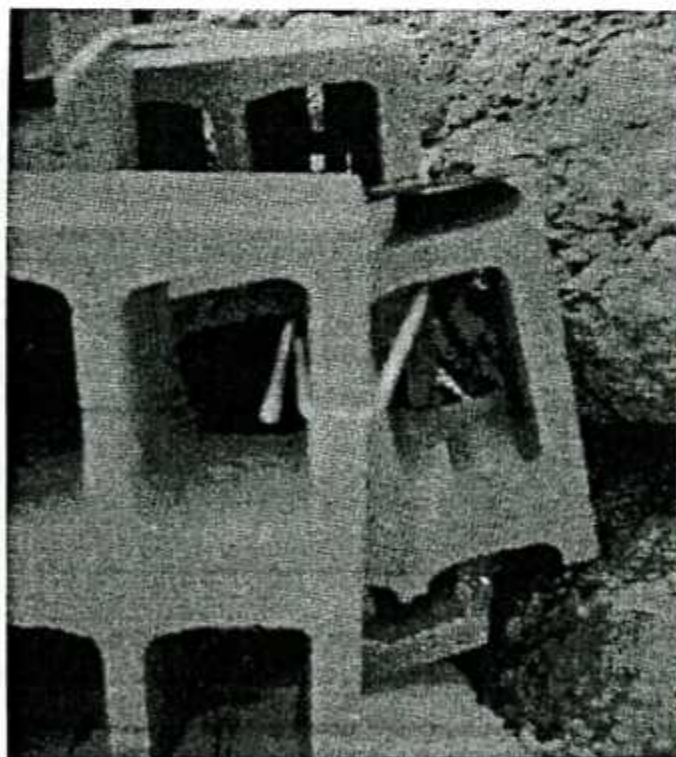
(4) Performance. Generally, the concrete blocks and galvanized-steel tie rods of the Sandgrabber withstood the natural forces of waves and tides. Some settlement was detected about 1 week after installation, but there was negligible differential shifting of individual blocks. One block and one tie rod were broken at the north end as the structure settled against the adjacent revetment stone (Fig. 2-619). Over the next 5 months, the structure continued to settle, rotating downward on the seaward side. This resulted in a few loose tie rods, but the blocks remained intact. During August 1979, the seaward settlement increased, with a seaward slope of 5° on the south end, 11° along the midsection, and 15° on the north end (Fig. 2-620). About eight blocks on the northern landside were broken apart by tension forces exerted by the tie rods as a result of seaward settlement (Fig. 2-621).

Figure 2-619. Broken block and tie rod, north end, Bellows Beach, Hawaii, 14 February 1979.

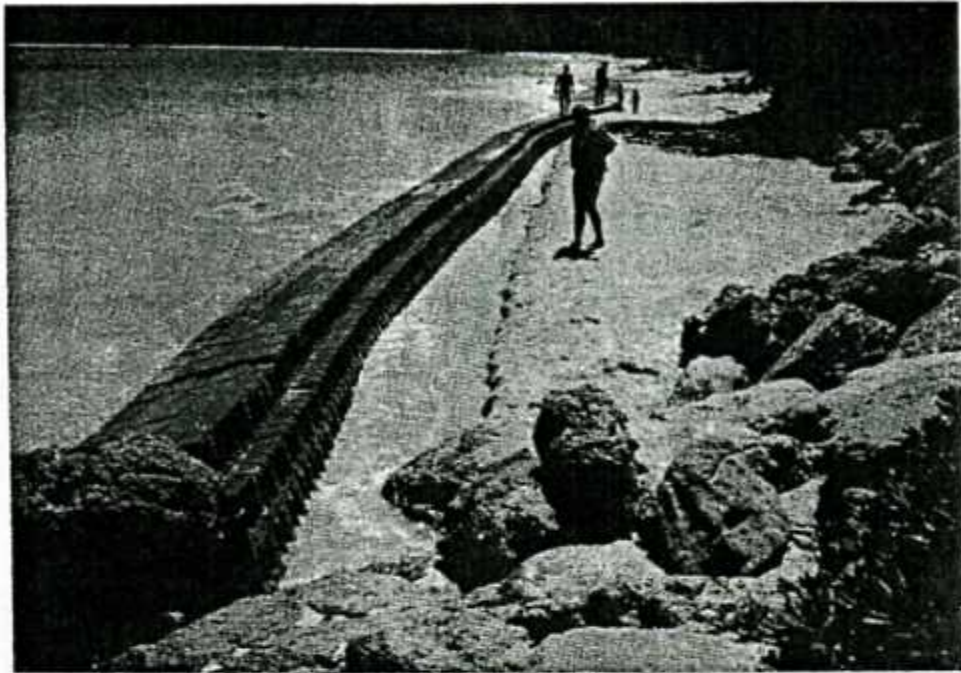
Figure 2-620. Seaward settlement of Sandgrabber, Bellows Beach, Hawaii, 5 September 1979.

Some structural performance problems developed at this site which a few comments might help to mitigate at future installations. First, since the sand at Bellows is fine grained, the settlement of the seaward side of the structure due to toe scour should have been anticipated, and bedding should have been provided or the foundation trench should have been excavated to the anticipated scour depth. Second, the Sandgrabber is not sufficiently flexible; it can be damaged by uneven settlement. This was clearly demonstrated at this site by comparing the north and south ends of the installation (Figs. 2-627 to 2-630). At the north end, the Sandgrabber settled on the adjacent, existing coral rock revetment and, due to inflexibility, was unable to conform to the scouring bottom (Fig. 2-630). As a result, the north end of the structure was damaged. This problem might have been avoided had the structure not settled as much, had the structure been more flexible, or had the north end of the Sandgrabber not been constructed such that it settled onto the rock structure. Third, if differential settlement of the Sandgrabber is anticipated, elastic "ties" of some sort might be substituted for the steel tie rods. This would eliminate the breaking of blocks that results from excessive stresses due to inflexibility of

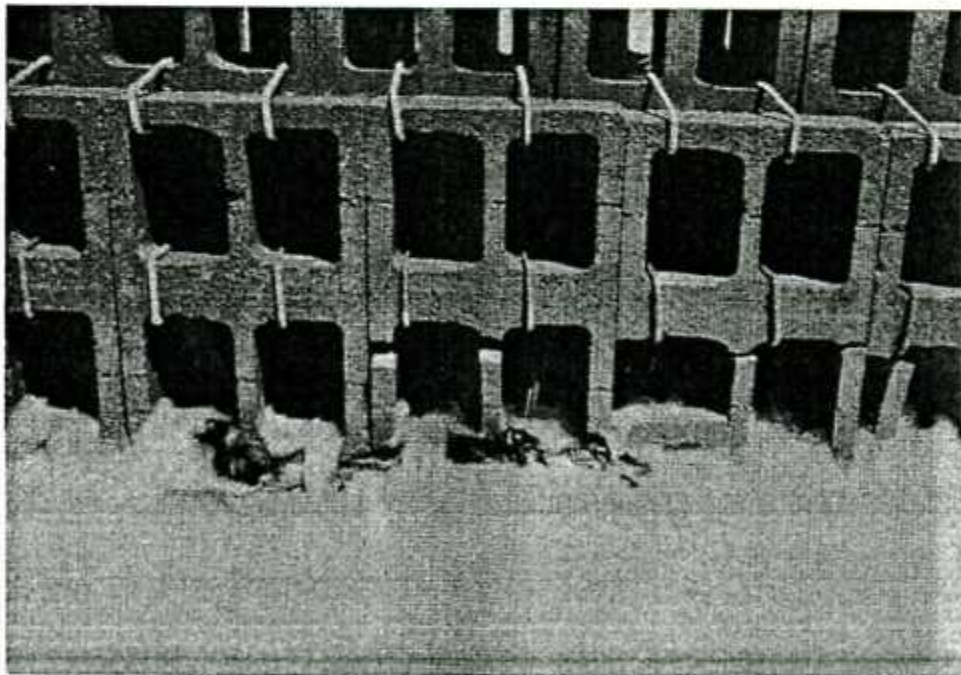
Figure 2-621. Broken blocks, landward side, Bellows Beach, Hawaii, 5 September 1979.

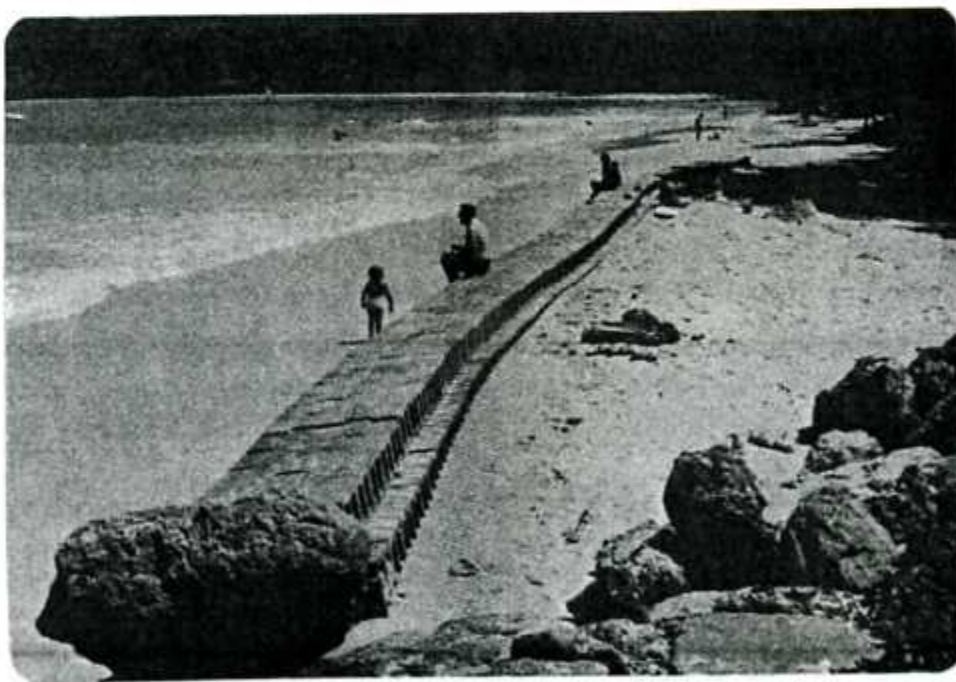
Figure 2-625. Scour beginning at the north end, Bellows Beach, Hawaii, 3 July 1979.

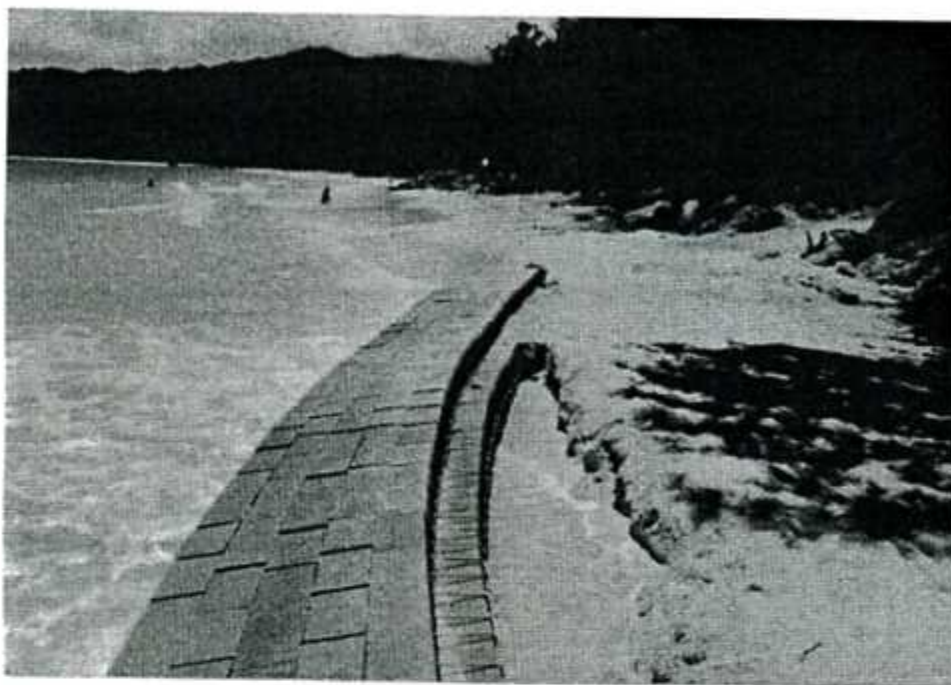
Figure 2-626. Trench working its way south landward of structure, Bellows Beach, Hawaii, 5 September 1979.

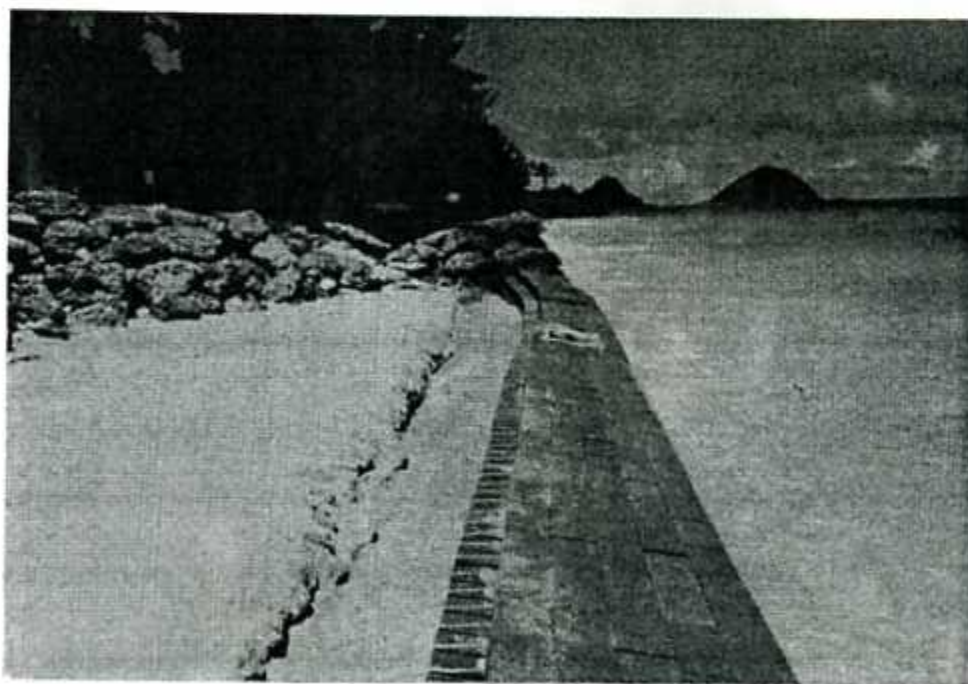
Figure 2-628. Scour trench along north end of structure, Bellows Beach, Hawaii, 5 September 1979.

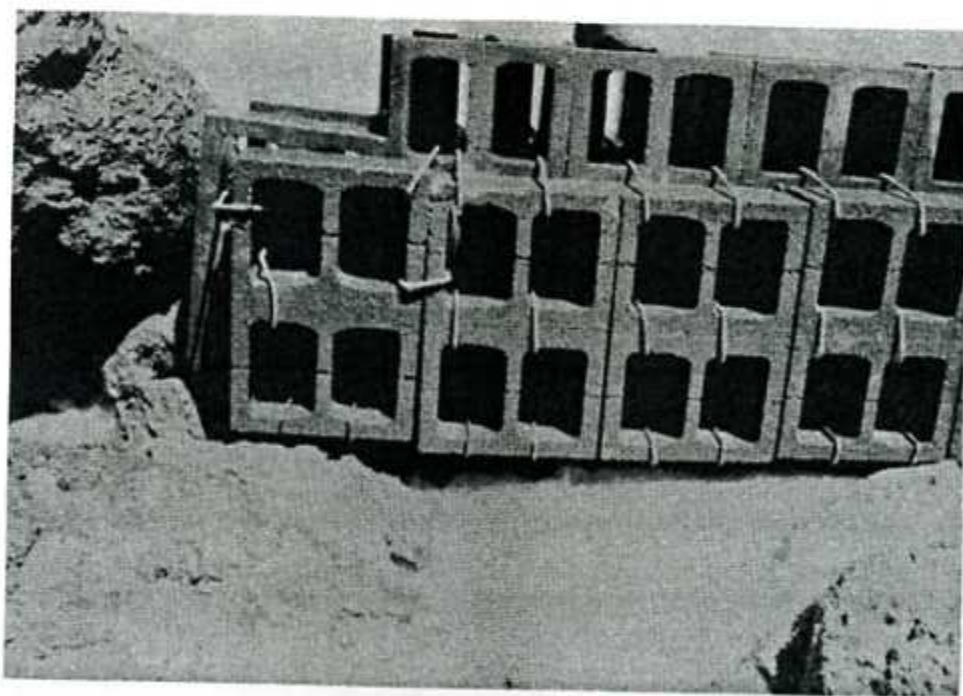
Figure 2-630. Landside of north end of Sandgrabber settling on the existing coral rock revetment, Bellows Beach, Hawaii, 5 September 1979.
